Built Form Typology and Design Guidelines

by Nathan Tseng and Garrett Klifman

Draft 30 March 2010

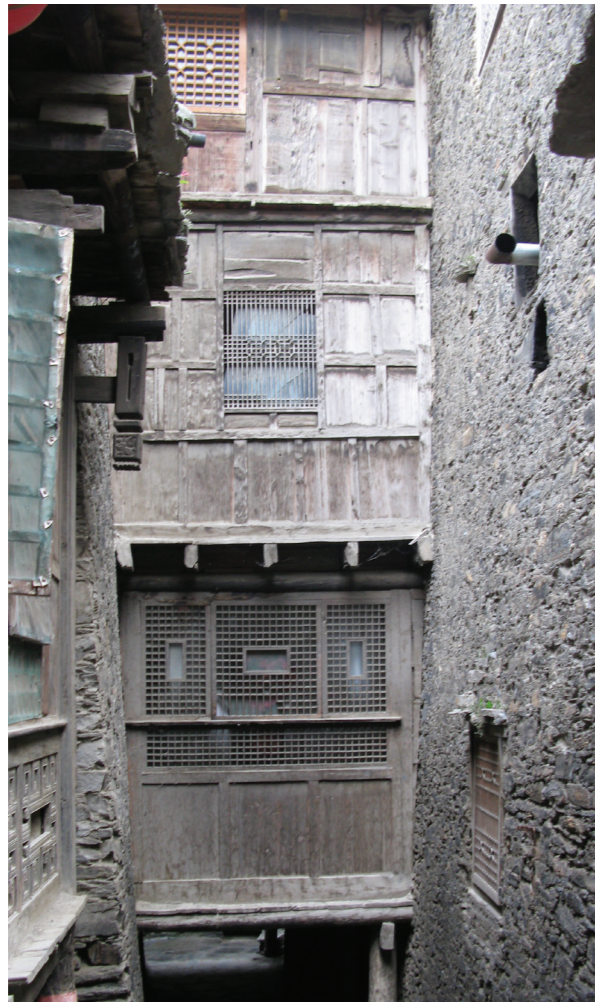
Figure 3.6 Buildings should be reconstructed to their original appearances

All buildings, regardless of damage should be **restored** to pre-earthquake state. Attempts to **repair** damage should be attempted before any type of **reconstruction** work is attempted. Reconstruction should use traditional building materials and methods of construction to restore the pre earthquake appearance as best possible. Following that all buildings should be **preserved and maintained**.

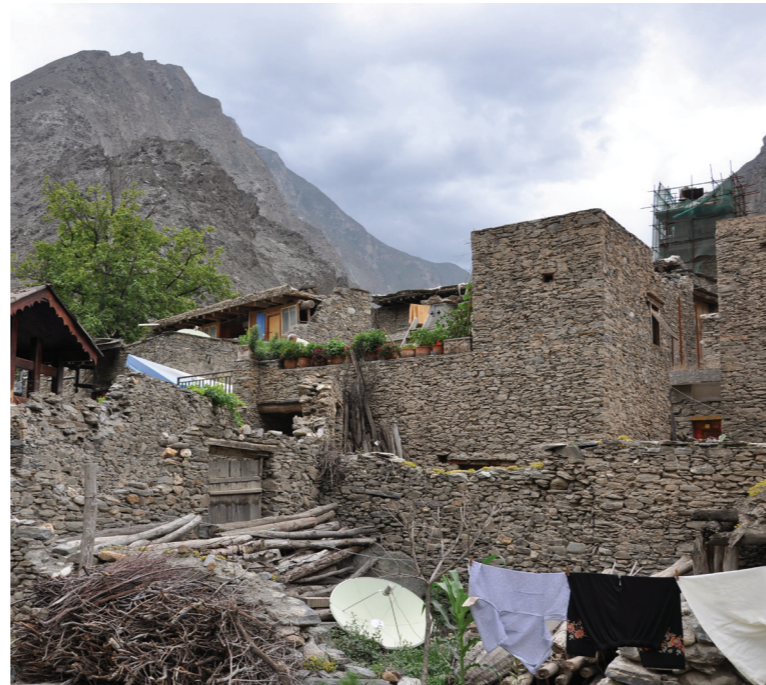
Figure 3.7 New infill development should be allowed if the original structure has sustained severe damage or has collapsed

New infill development on the original building site should be allowed when a building has sustained greater than 50% structural damage.

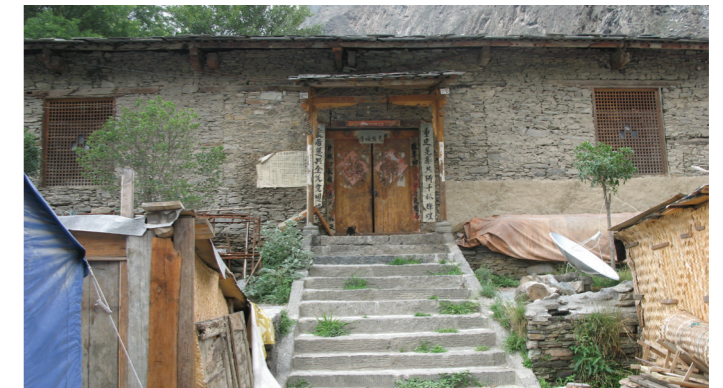
Figure 3.8 Building close to the historic core should be subject to more design controls depending on level of damage

Buildings that are directly adjacent to or bordering the 100 year core should be **repaired** to the pre-earthquake state if there is minor damage but allowed the flexibility of **modification**. If there is significant damage, **infill or reconstruction** on the site should be allowed.

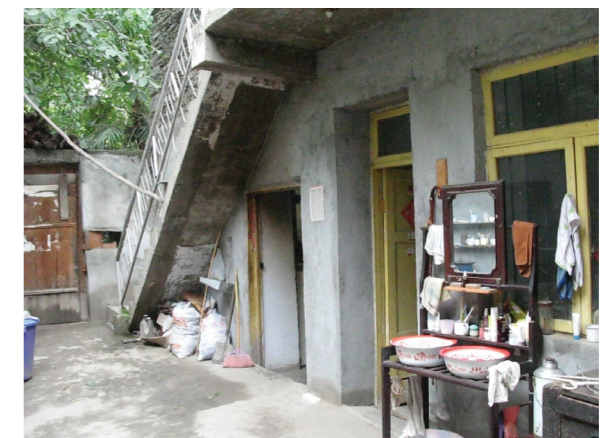
Figure 3.9 Newer buildings out in the periphery should be given more flexibility on construction

Buildings not bordering the 100 year core should be given flexibility to **modify, modernize, construct new infill, or reconstruct** as long as new construction guidelines are followed.

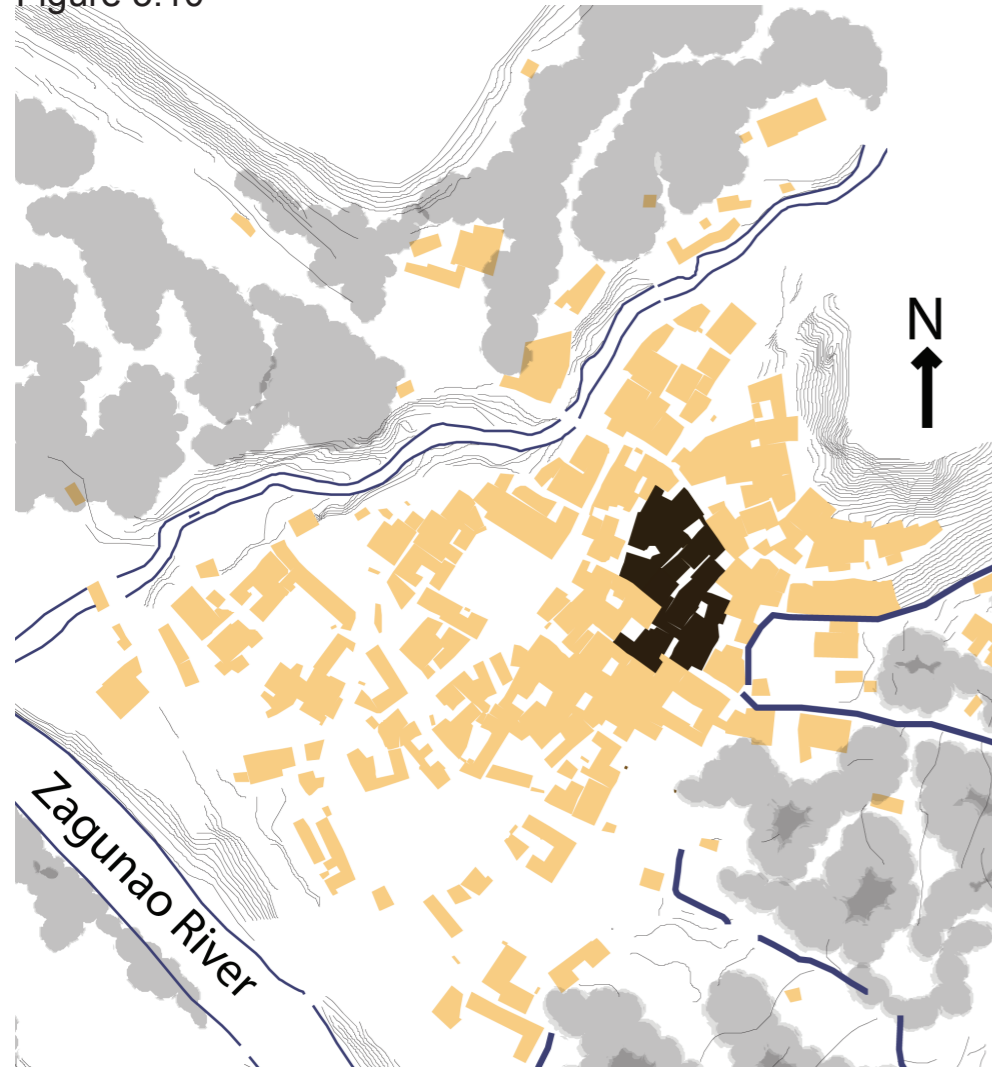
Figure 3.10

1000 year Core - Restoration

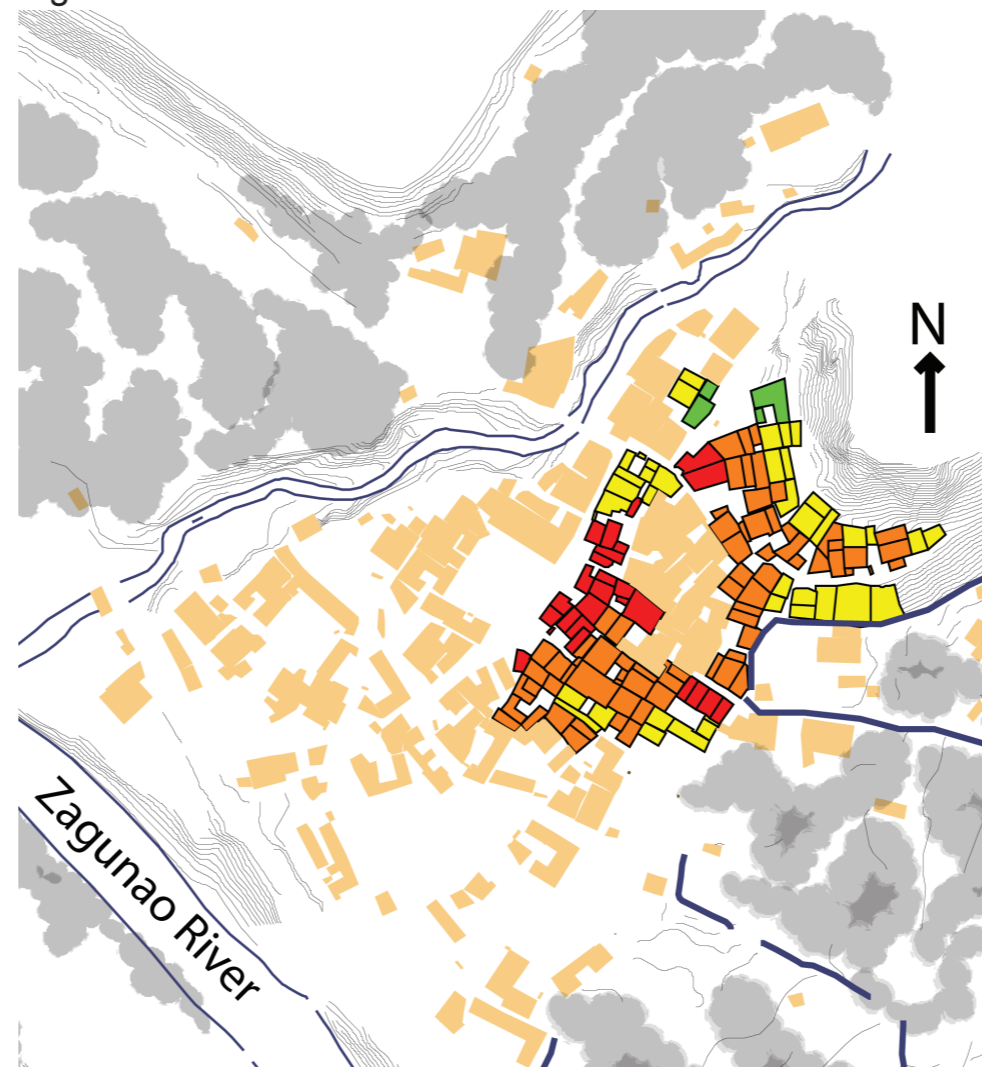
Figure 3.11

Collapse - Replacement/Infill
 Major Structural Damage - Modification/Infill
 Minor Structural Damage - Modification
 Cosmetic Damage - Preserve & Maintain

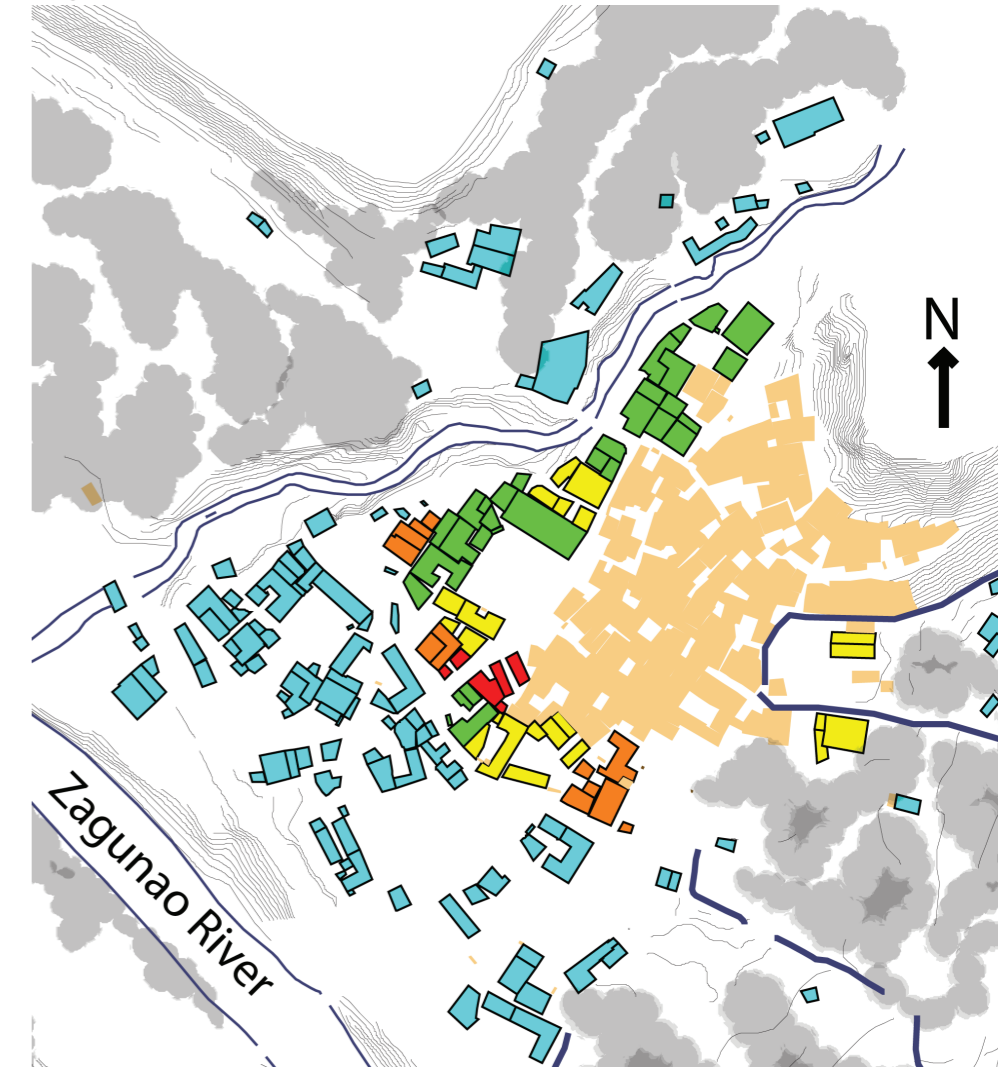
Figure 3.12

Inner Periphery
 Collapse - Replacement/Infill
 Major Structural Damage - Modification/Infill
 Minor Structural Damage - Modification
 Cosmetic Damage - Preserve & Maintain
 Outer Periphery
 Basic Design Guidelines

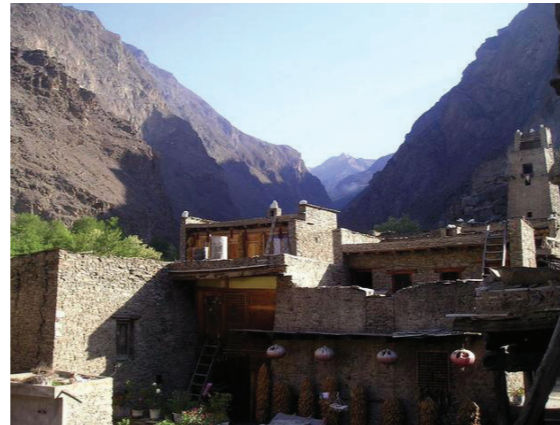
Figure 3.13 Typical 100-year core development pattern including watchtowers.

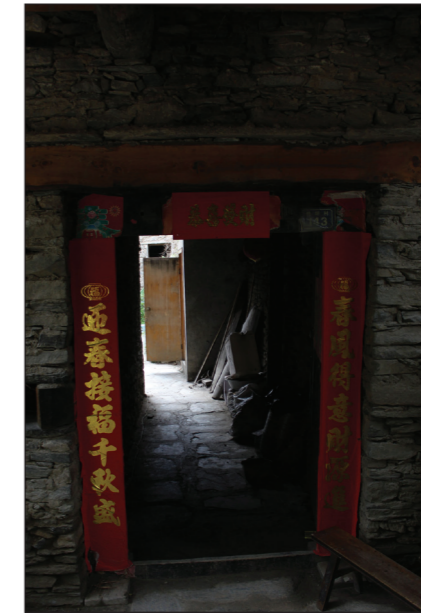
Figure 3.15 Courtyard entry in 100-year core

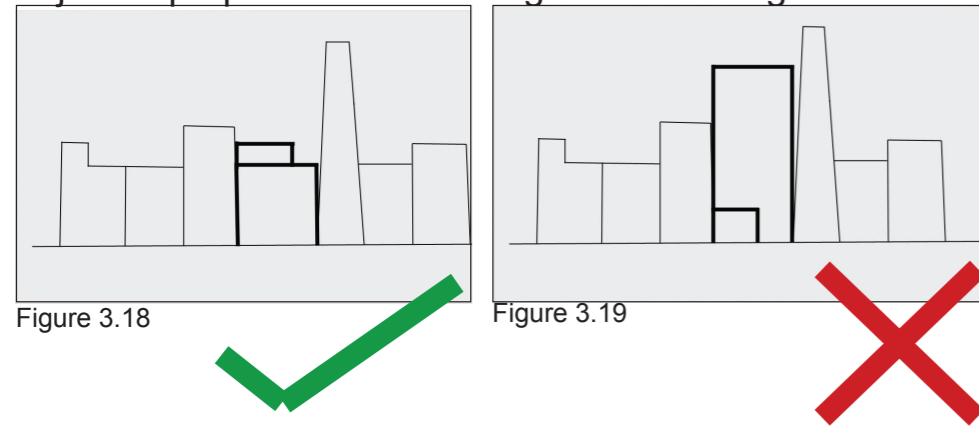
Building Height- An infill building should not be much lower or higher than the height of surrounding structures. Roof-lines of infill development may vary in height, but the general height of the existing facades should be maintained, 7.5 to 13.9 meter height limit, excluding watchtowers. Although, individual structural height will vary by location, structures' heights in floors should be within one floor of adjacent properties to encourage vertical integration.

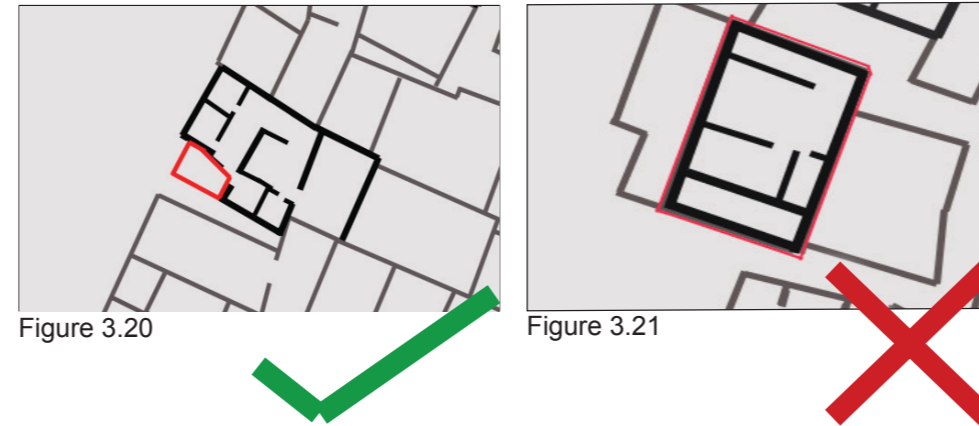
Lot Coverage and Open Space- Lot coverage refers to the percentage of each land plot that is occupied by a building or permanent structure. The percentage of land left undeveloped is for building setbacks and open space such as courtyards. The appropriate range of lot coverage is 65% to 86.6% for structures with the remainder of the lot reserved for open space.

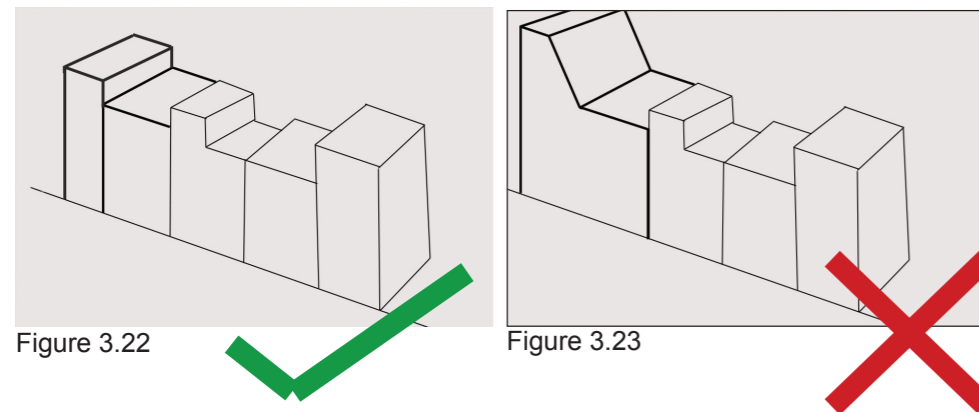
Building Volume and Mass- Projects should demonstrate evidence in their designs that they have studied predominant scale and proportions of the area in which they are proposing to build. New construction should be massed and have volumes similar to historic structures. Building volumes should be within 702.1 to 1285.7 cubic meters.

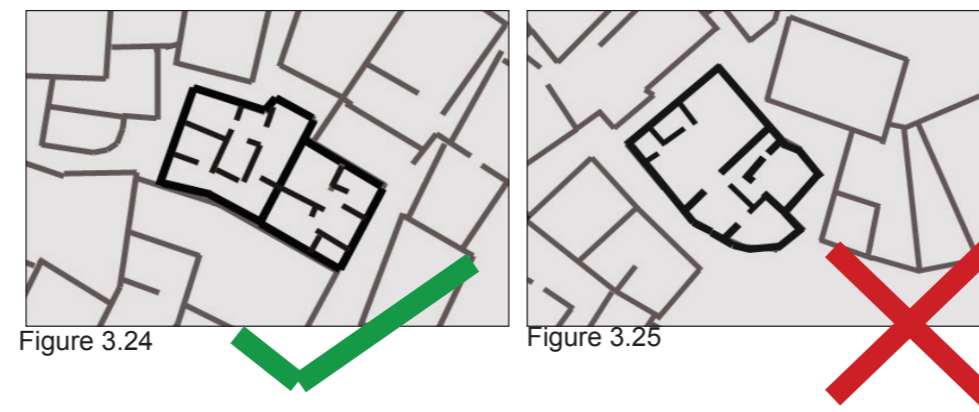
Shared Walls- Shared walls among structures in the historic core are a character defining feature of the Taoping Typology. All historic structures examined exhibit shared walls with adjoining buildings. New infill development in the historic core should have between 27% and 50% of exterior wall length as shared walls with adjacent structures.

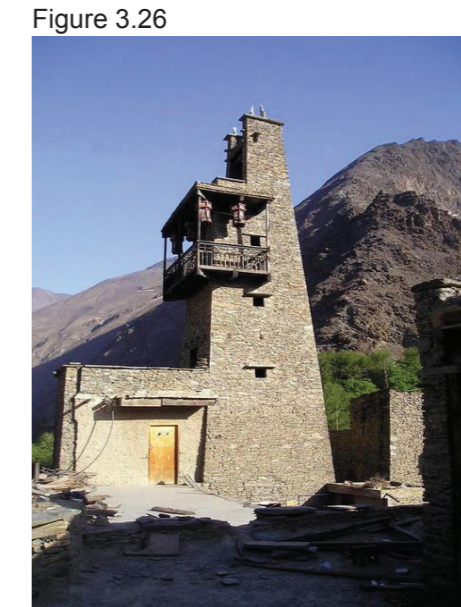
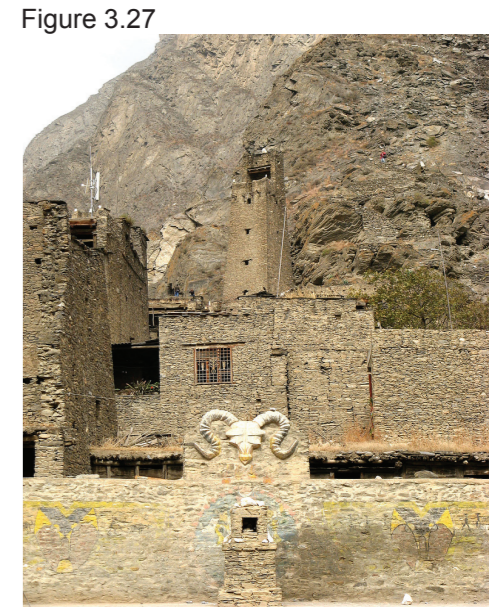
Windows- Windows should be spaced evenly and far apart. Optimally windows and doors should be spaced every 3 m or more. If a wall faces another wall of a distance less than 2m away, there should not be any windows on that face unless it is of the "Dou" (斗) window type. These Dou windows should also be spaced every 3m or more.

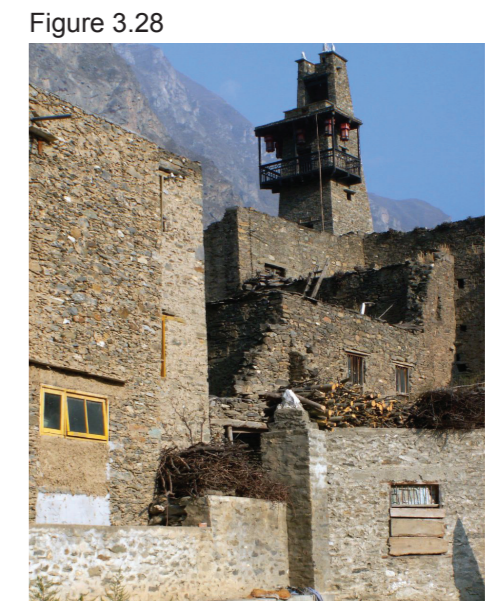
Fenestration- Fenestration rates of buildings in the 100-year core should not exceed 10%.

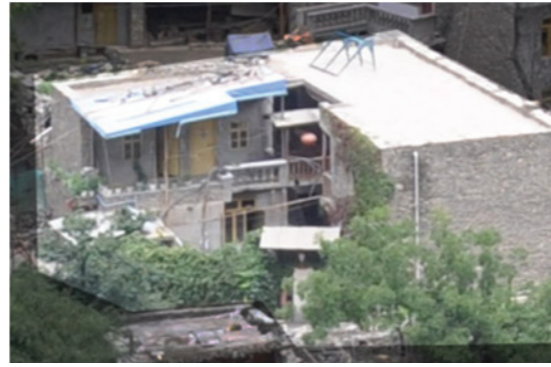
Figure 3.29 Typical periphery dwelling

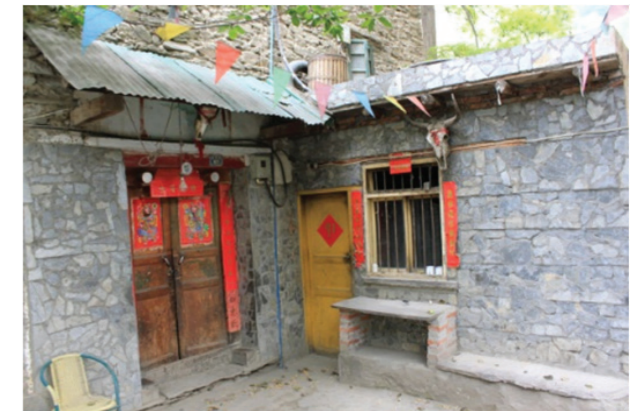
Figure 3.32 Peripheral development with modern materials and larger fenestration

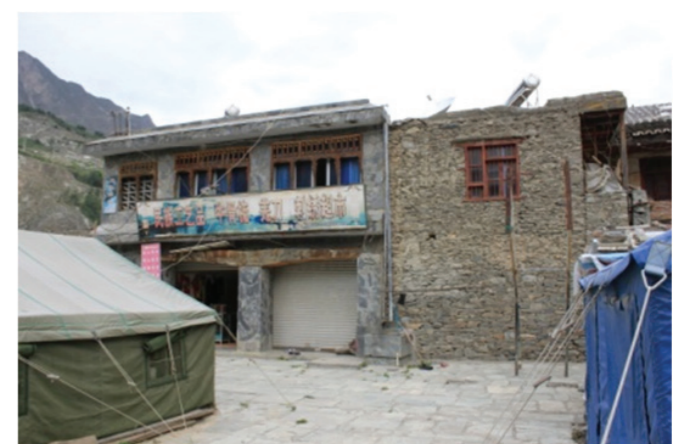
Figure 3.42

Fenestration- Fenestration rates should be higher in the periphery due to larger window sizes. A recommended fenestration rate is between 10% and 50%.

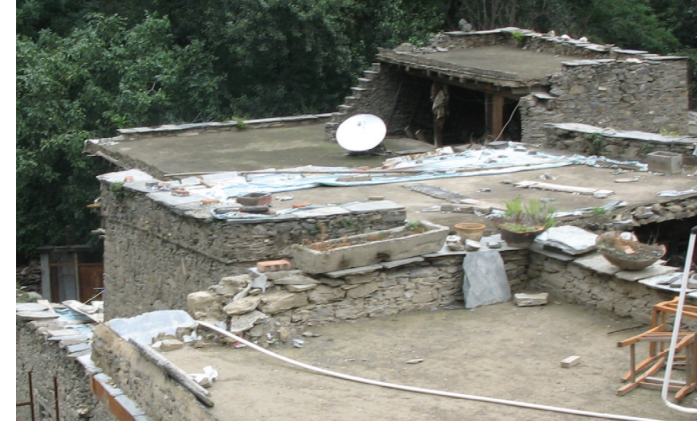
Figure 3.48

Current
Existing half-roof.

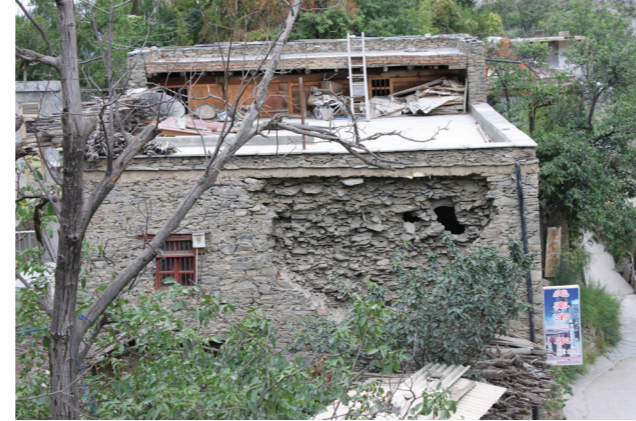
Figure 3.51

Current
Section of building facade has been damaged by earthquake, creating a gap and missing section of the wall

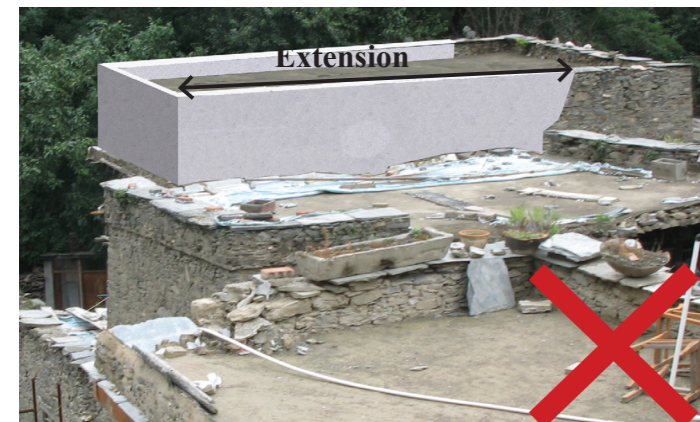
Figure 3.49

Incorrect
Extension uses inappropriate material, and extends over 50% of roof area, creating an unsightly addition to the property

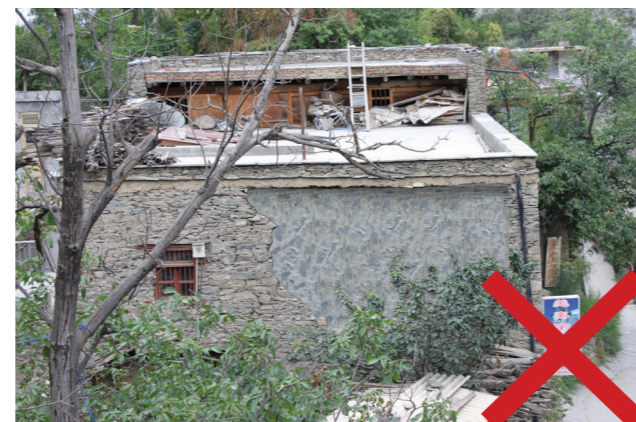
Figure 3.52

Incorrect
Wall has been filled in with new stone material. However it doesn't match the original, creating a discontinuity on the facade

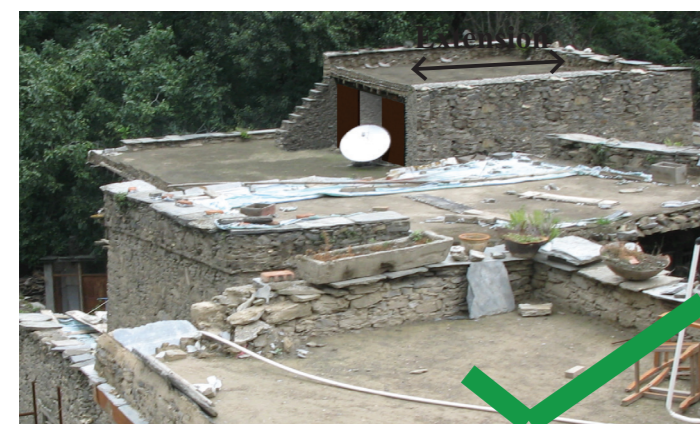
Figure 3.50

Correct
Use of material similar to rest of building, extension does not exceed 50% of floor area.

- 1) Replacement roof material should match original material and color as much as possible
- 2) If a building with an existing flat roof does not have a half floor, one may be constructed, provided it does not exceed 50% of the floor area or damage historical or structural integrity of the building.
- 3) A half floor previously modified in the past 50 years may be may be extended to up to 50% of the floor area.

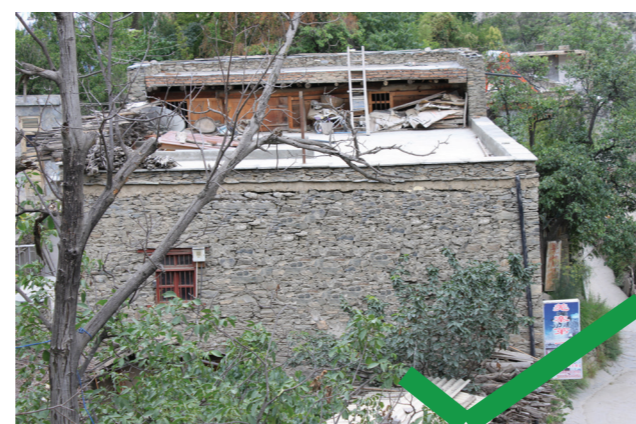
Figure 3.53

Correct
Wall has been filled in as best as possible with material that matches the surrounding sections of the facade.

- 1) Historic materials (wood, metal, stone) and designs of walls, ceilings, floors, doors, windows, and other architectural elements should be retained as best possible.
- 2) Material should be replaced only if deteriorated beyond repair.
- 3) Damaged sections of the building should be repaired as best possible. Missing sections of the building envelope should be filled with material that matches surrounding material.
- 4) If replacement of an architectural element is necessary, the replacement should match the original as best possible in texture, size, color, and physical properties. Building façades should be reconstructed using past techniques.

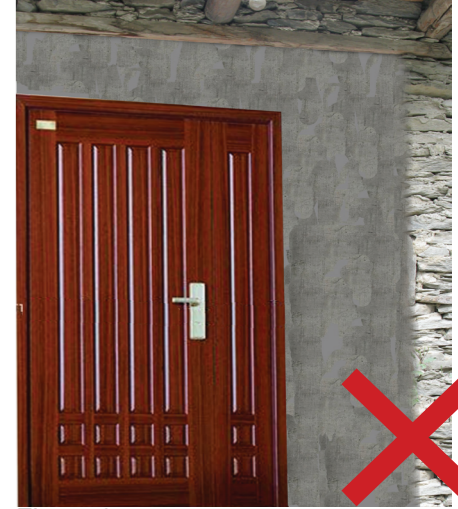
Figure 3.47

Incorrect: Doorway has been resized with mismatching infill wall materials. The door color matches the original but the style is different.

- 1) Existing door and window locations and dimensions should not be altered and any replacements should be of same dimensions.
- 2) Fenestration rates should be kept constant.
- 3) Historic doors and windows should be retained as best possible
- 4) Doors and windows should only be replaced if condition is beyond repair.
- 5) Doors and doorways of courtyard entrances and main entrance door ways shall retain historic motifs and engravings. If a replacement is necessary, the original doors should be matched as best possible.
- 6) "Dou" (斗) windows should not be altered or covered by any material unless it presents a danger to human life.

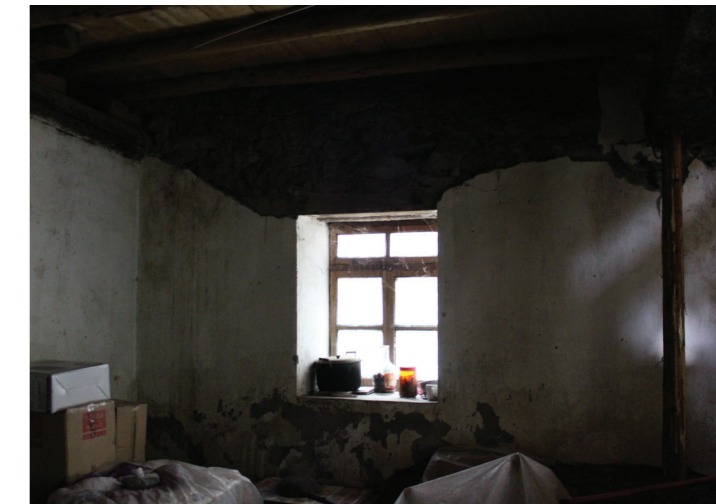
Figure 3.54

Current
Example of a secondary space in a Taoping home. This is currently being used as a store room. There is greater flexibility in these types of spaces for change.

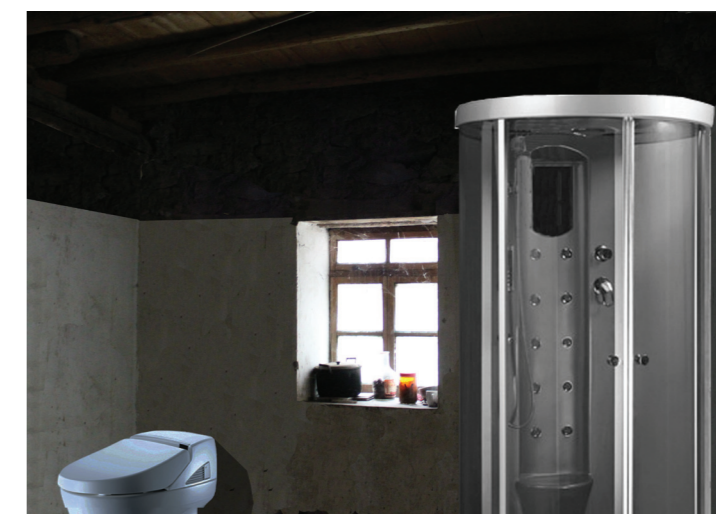
Figure 3.55

Proposal
The room could be partitioned and turned into a new modern use. One part could be turned into a modern bathroom such as this. Such a room could also be used to house modern infrastructure requires for such a use like piping

- 1) Existing floor plans and interior spaces that are important in defining the overall historic character of the building should be retained. Subdivision of primary spaces should be avoided if possible. Elsewhere, it should be considered only if it would not damage the structural system of the building. New functions such as bathrooms should be placed in secondary spaces.
- 2) Interior features and finishes important in defining the overall historic character of the building should be retained.
- 3) Stairs should be retained in their historic configuration and location. New stairs should be constructed in secondary spaces.
- 4) Painting over previously unpainted walls, ceilings or floors should be avoided.
