# Commencement Bay (Tacoma, WA) Nearshore Salmon Habitat Assessment

Final Report to be Submitted to Pierce County

**Bonnie Becker, Jamie Gruber, Canyon Little, Shawn Buck, Mitchell Crawford,  
Zachary Griswold, Travis Irving, Staci Johnson, Katherine Patterson,  
Shristi Prakash, and Bridget Mason  
University of Washington Tacoma  
July 2009**

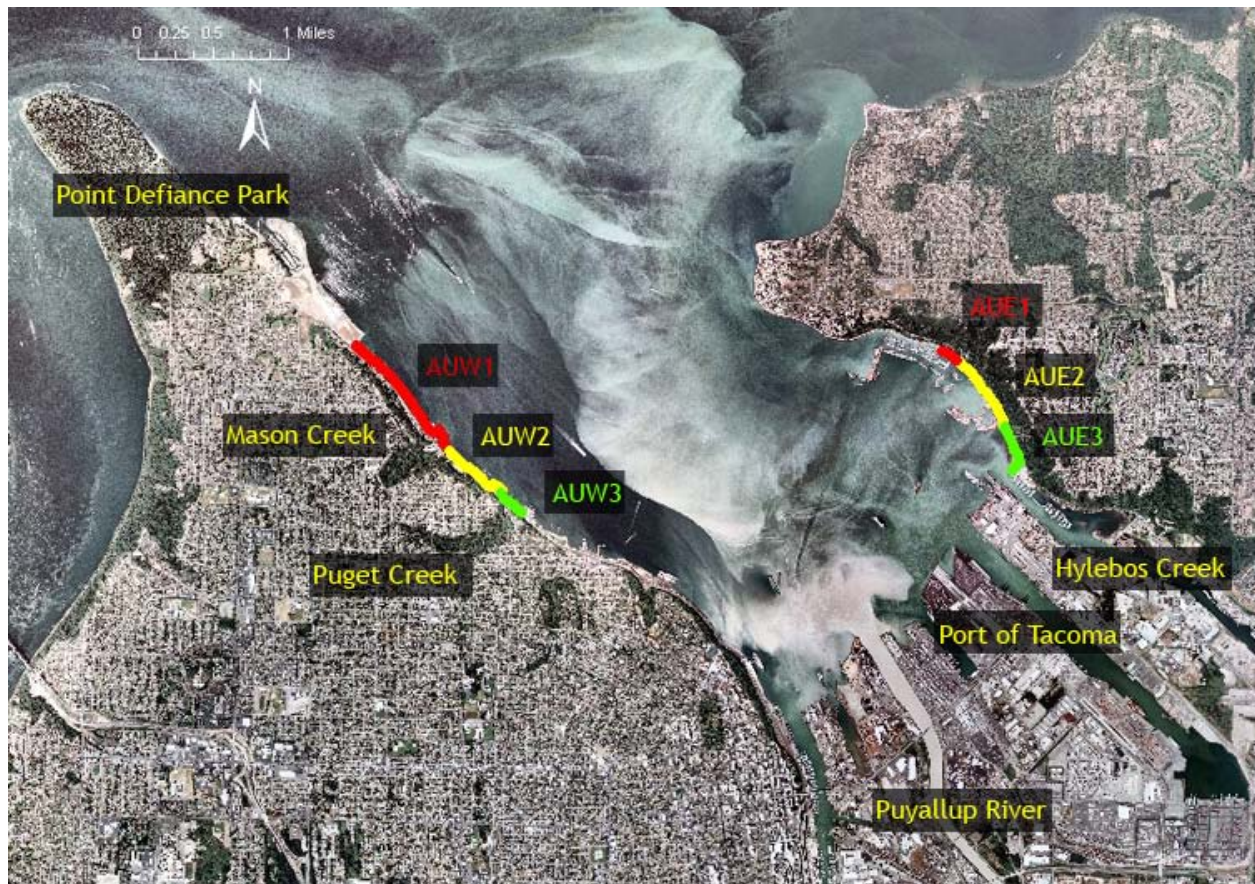
Figure 2. Map of Commencement Bay highlighting the Assessment Units (AUs) defined in this study. Includes local freshwater sources and other landmarks.

Due to our limited resources, we decided to focus on part of Commencement Bay. These AUs were chosen using a collaborative process and existing GIS data. Students worked in teams of two to choose six AUs based on attributes they felt were important, such as presence of eelgrass or amount of riparian vegetation. Ultimately, we focused on substrate type and manmade structures to choose homogenous areas that were easily accessible by foot without special permission. We chose three AUs on each side of the Bay: three on the east side along Marine View Drive (from north to south, AUE1, AUE2, AUE3), and three on the west side along Ruston Way (from north to south, AUW1, AUW2, AUW3). The original border between AUE1 and AUE2 was changed in the field after we observed that the distribution of substrates was different than expected from the existing data (Figure 2).

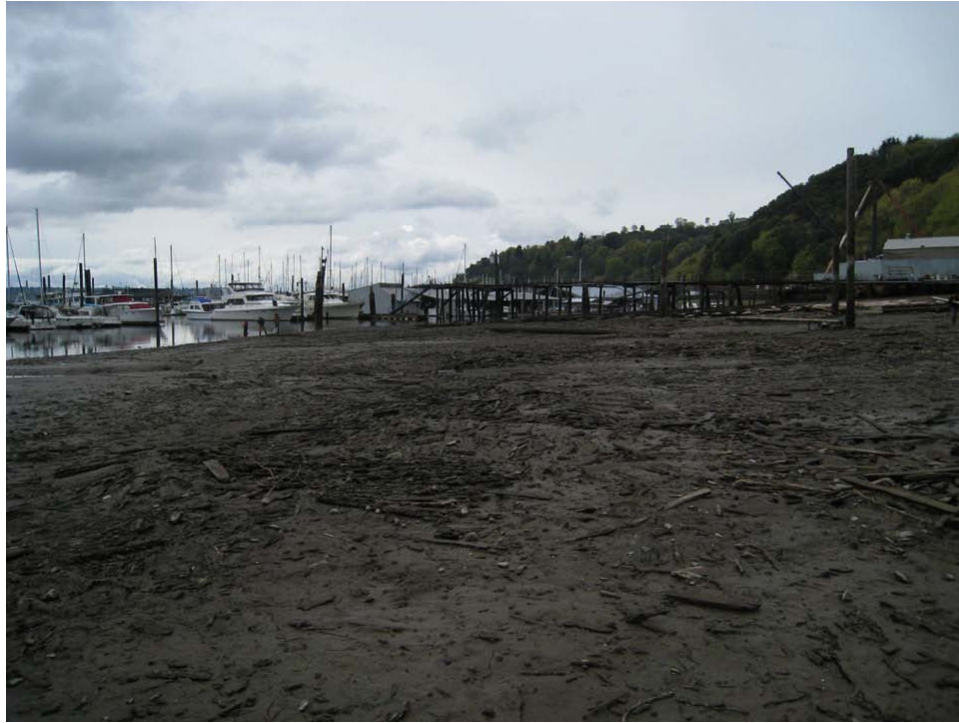
Figure 3. AUE1 overview showing muddy substrate and wood debris. (Photo by Bonnie Becker)

AUE1 is a small stretch of shoreline (approximately 760 feet) located within the Crow's Nest Marina, between the two most southerly docks of the marina complex. The substrate is covered with very soft mud (Figure 3). Old wood waste is embedded within the mud. This AU has been highly modified due to the marina that contains it. There are bulkheads and overwater structures covering most of the AU (Figures 4 and 5). The slope of the substrate in this AU was low, averaging around two degrees. There is a floating dock that marks the southern end of this AU; beyond this dock the substrate changes dramatically.

The shoreline is very straight along AUE1, so the ratio that we found indicated a shoreline complexity of <1.2, which scores a 1 on the report. The slope is on average 3 degrees in this AU making it low gradient, scoring a 3. More than 50% of this AU is considered to be in the littoral zone, which scores a 3 on the report. A score of 3 was given since the substrate in this AU was mud or mixed fine grain sediments on over 50% of the AU. This AU was very muddy which

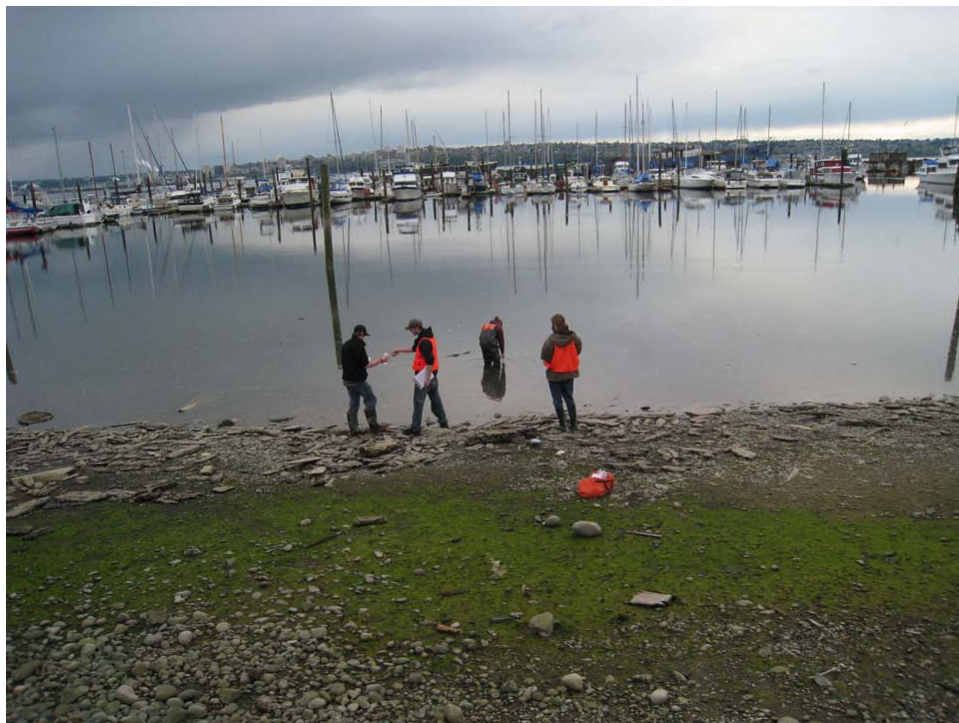
Figure 4. AUE1 showing overwater structures (docks). (Photo by Bonnie Becker)

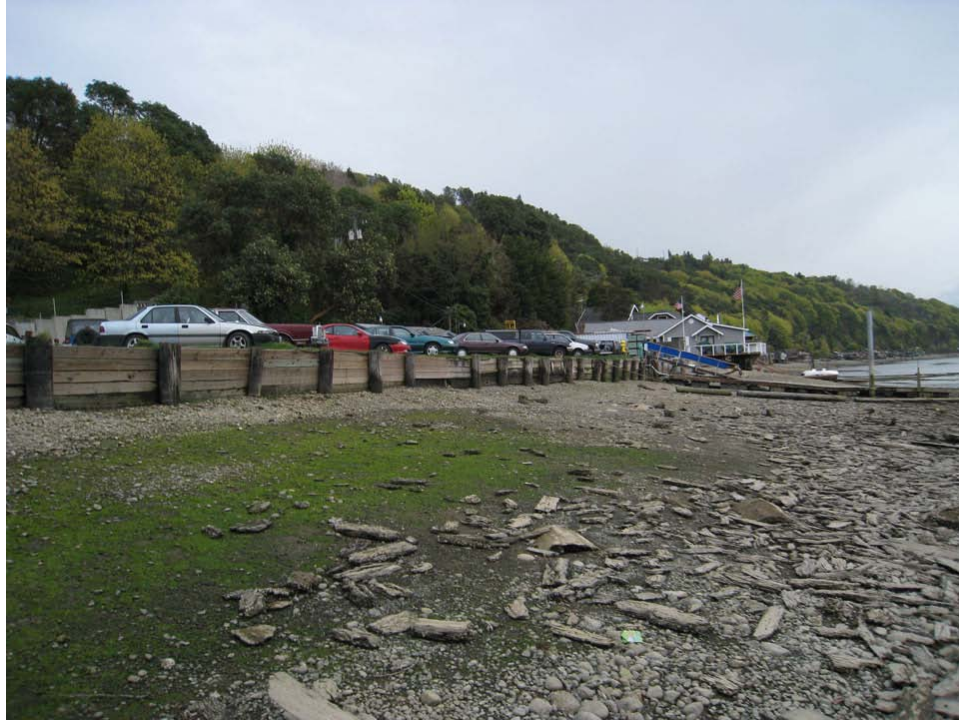
Figure 5. AUE1 is bulkheaded along the length of the shoreline. (Photo by Bonnie Becker)

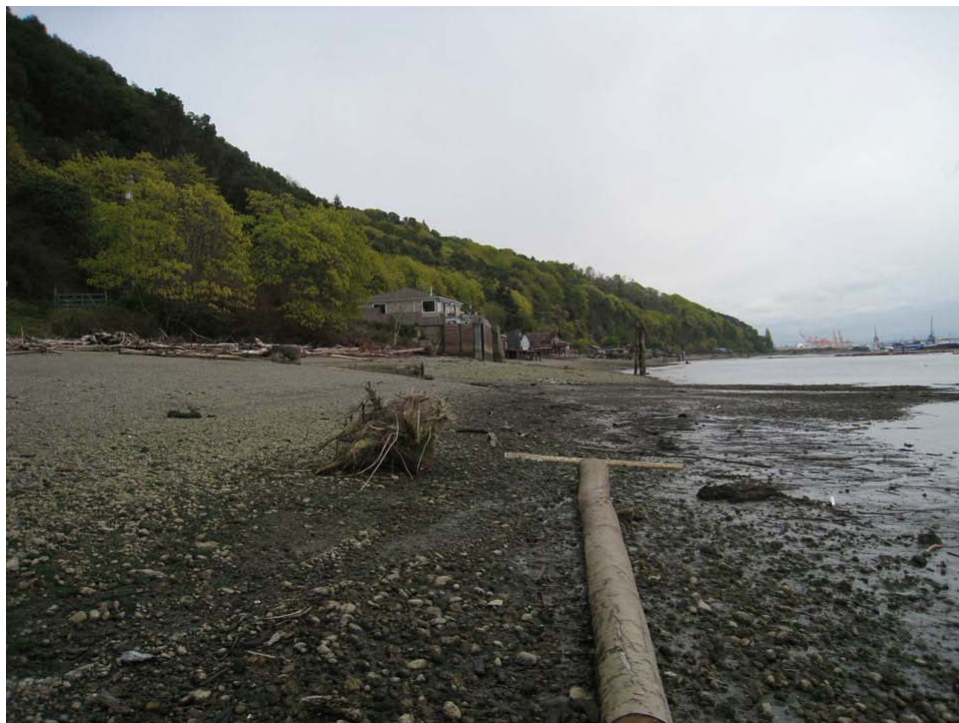
Figure 6. AUE2 overview showing houses and personal docks. (Photo by Bonnie Becker)

AUE2 is just south of AUE1 and is also the longest AU on the east side (approximately 3000 feet). It is a residential area, so it has many overwater structures such as private homes and docks (Figure 6). The sediment there is medium sized stones to fine grained sand (Figure 7). It had large woody debris present in small amounts and an edge of riparian vegetation, though non-native plants such as the Himalayan Blackberry dominated (Figure 8). The slope in this area was also very low, averaging about six degrees.

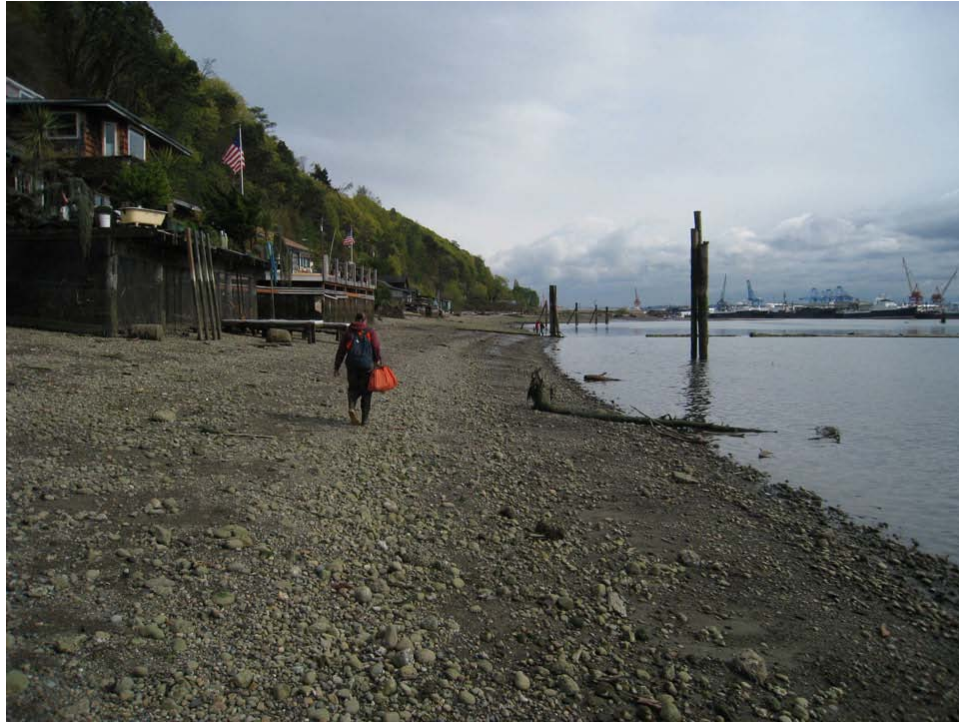
Figure 7. AUE2 substrate ranges from medium cobble to fine mud. (Photo by Bonnie Becker)

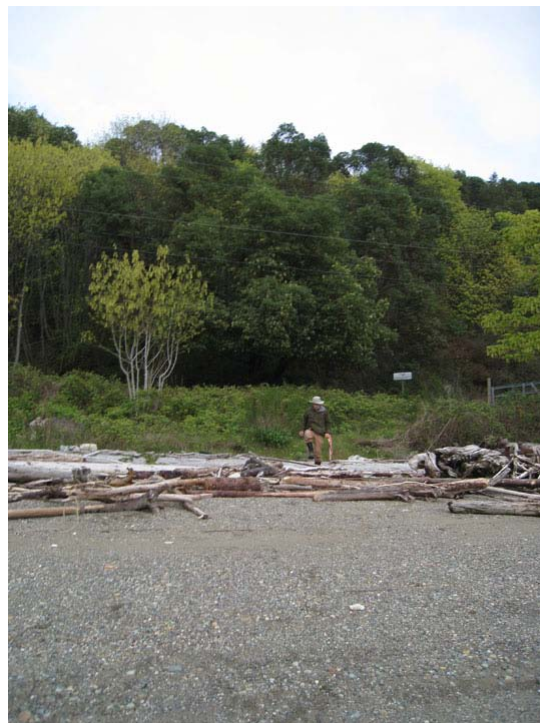
Figure 8. Riparian habitat in AUE2 is dominated by invasive species. (Photo by Bonnie Becker)

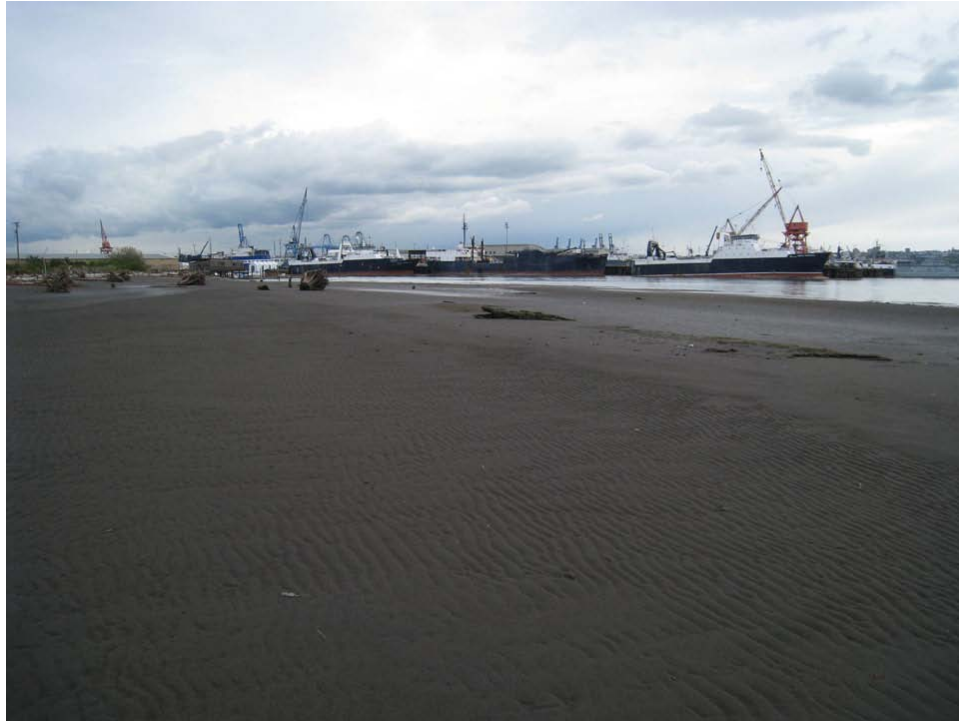
AUE3 starts south of AUE2 and ends at the mouth of the Hylebos Waterway (approximately 1350 feet) and consists of a large sand flat (Figure 9). There is a concrete bulkhead extending out into the Bay that separates this AU from the Hylebos. There are no homes located within this AU and no bulkheads or docks located within the AU. There is a functional tidal channel that is part of a past restoration effort (Figure 10). Shellfish and waterfowl were noticed in the vicinity. The substrate of the area is fine grained sediments and sand. The slope of the area was very low, around 1 degree. We believe that this sand flat was artificially created from dredged material from Hylebos creek. We have anecdotal reports that although it looks like a depositional area, it is actually eroding. This area is commonly known as the Skookum Wulge restoration site.

Figure 9. Overview of AUE3. (Photo by Bonnie Becker)

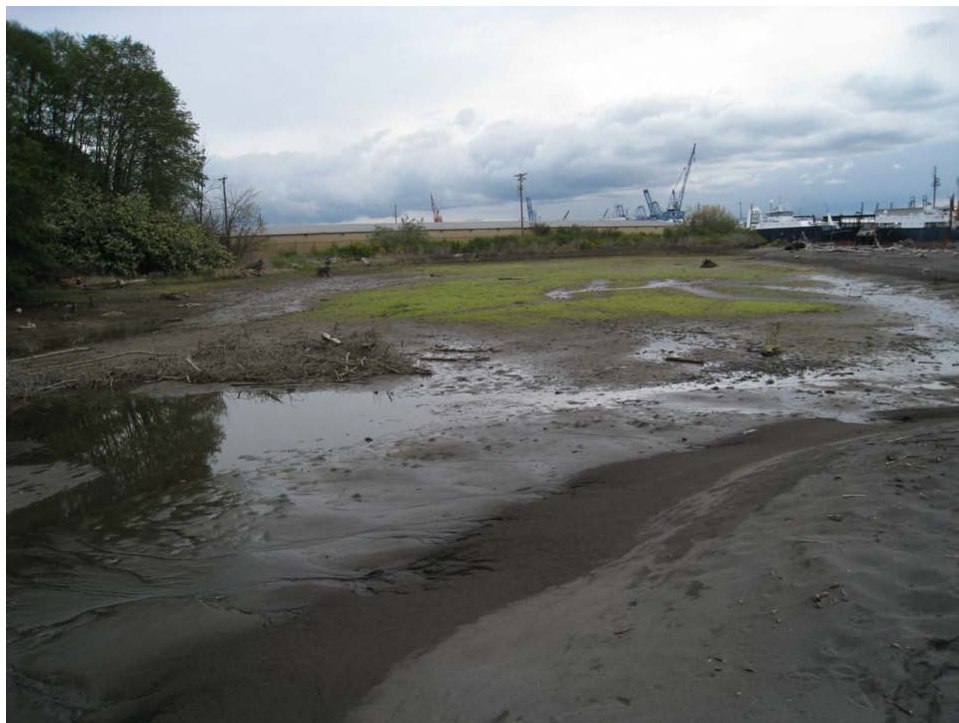
In AUE3 there were only two perennial water sources. The third AU was not depositional either and was highly erosive. There was no bulkheading or overwater structures found in this AU. This was the only AU in our study that had a tidal channel. This was an important indicator because AUE3 received a multiplier of 1.5 which raised its score compared to the other units significantly. This tidal channel was considered to be “sinuous”.

Figure 10. AUE3 contained a tidal channel. (Photo by Bonnie Becker)

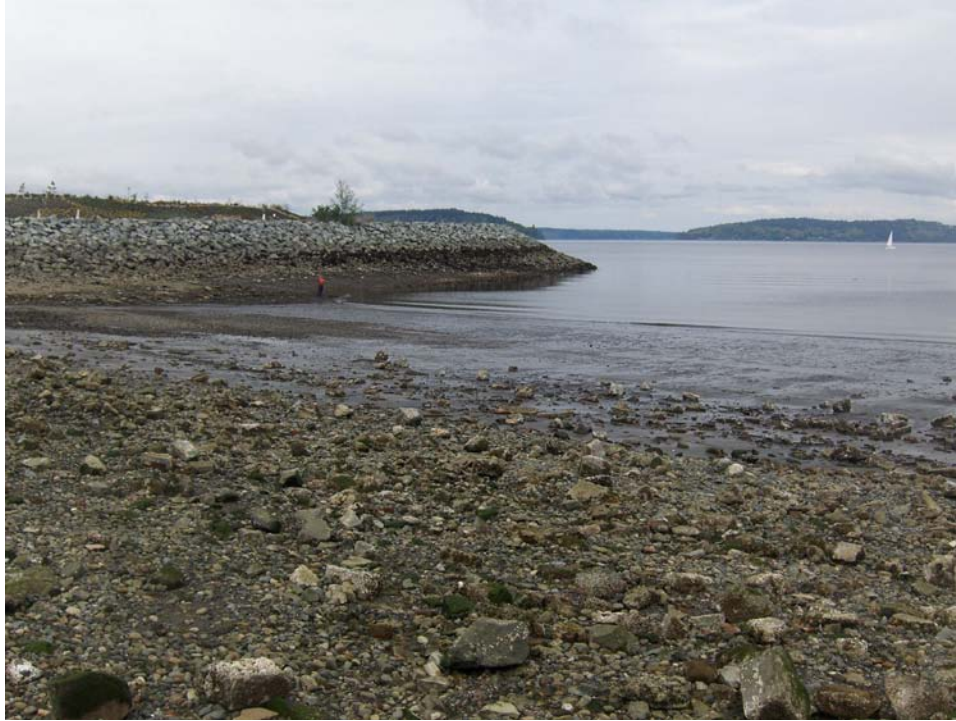
AUW1 is the longest AU on the west side (approximately 5200 feet) and is comprised of a sand-and-gravel beach culminating at heavily modified riprap armoring lining Ruston Way (Figure 11). The beach is relatively uniform with a low-grade slope. At the westernmost portion, there is a small freshwater spring flowing from an underground source, most likely stormwater that flows from underneath the road (Figure 12). Due to armoring at its boundaries, the AU is fairly protected from wind and waves. There is a supply of large woody debris, but there is no existing riparian or marsh edge at this site. Along the low tide line there is a series of pilings that hinted to a history of industrialization in the area (Figure 13). Additionally, there was also a lot of litter along the shoreline that included a large screw and a tire (Figure 14).

Figure 11. AUW1 overview. (Photo by Canyon Little)

AUW1 has experienced quite a bit of shoreline modification, as the upper shoreline is backed onto Ruston Way, and is bulkheaded with riprap revetments along its length. The shoreline is armored along more than 50% of the shoreline, with the majority of the riprap dipping below MSL. This led to two negative multipliers, of 0.7 and 0.8 for questions 30 and 31. There is also a pier and overwater structures in this area that led to two additional negative multipliers of 0.9 and 0.7 for questions 32 and 33. There is a non-navigable freshwater spring flowing from the rocks, as shown in Figure 12; however, it provides no migration route for young salmon, as it flows out from a small source that goes under Ruston Way.

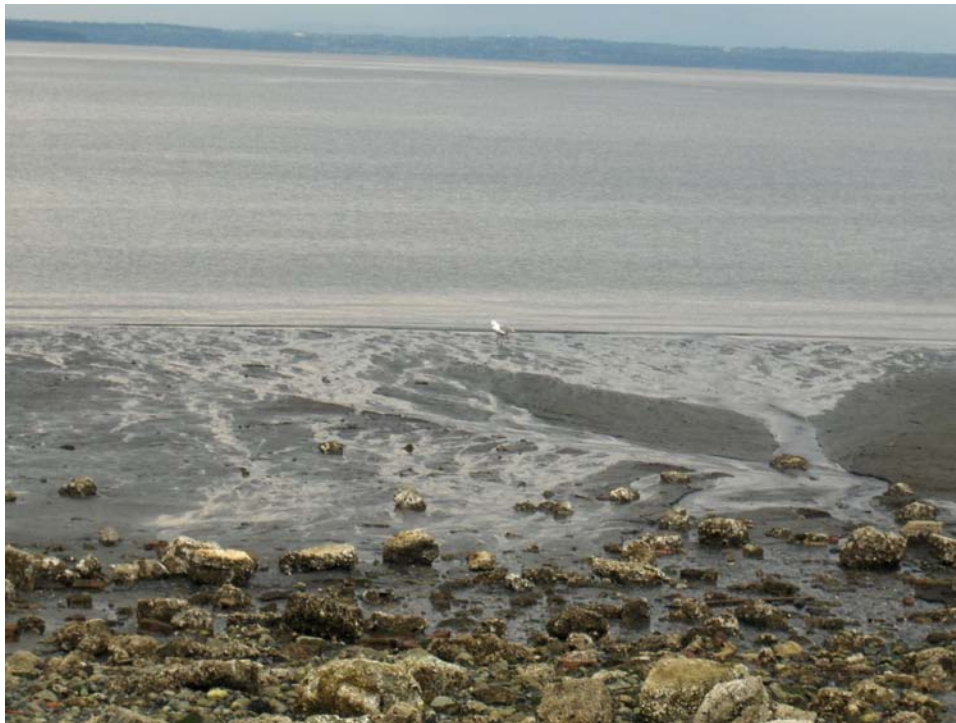
Figure 12. Small freshwater springs in AUW1. (Photo by Canyon Little)

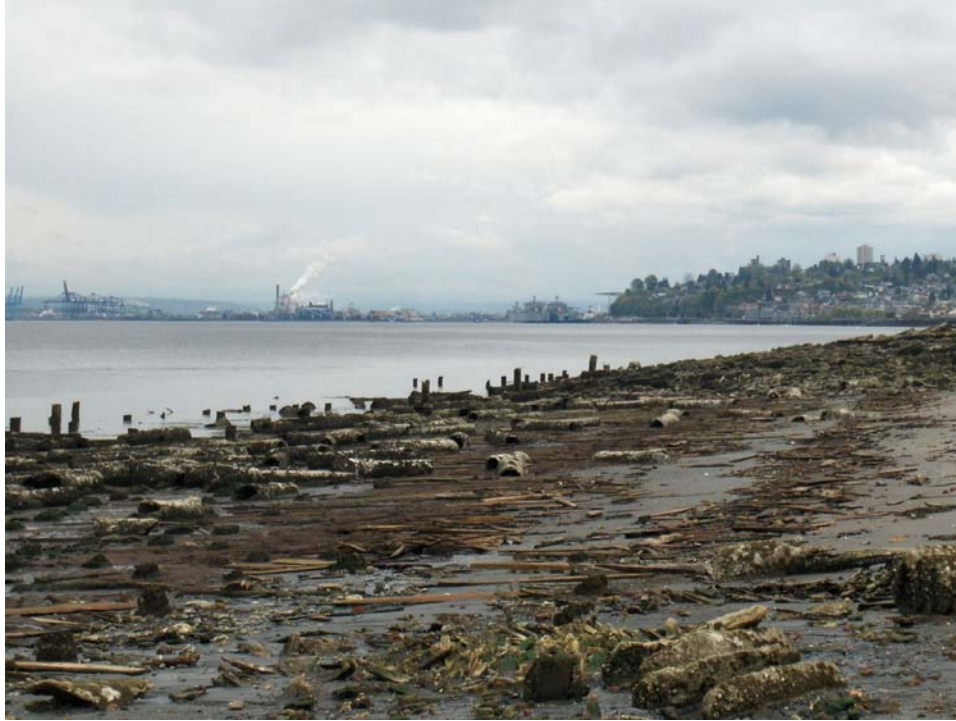
Figure 13. Old pilings and wood debris in AUW1. (Photo by Canyon Little)

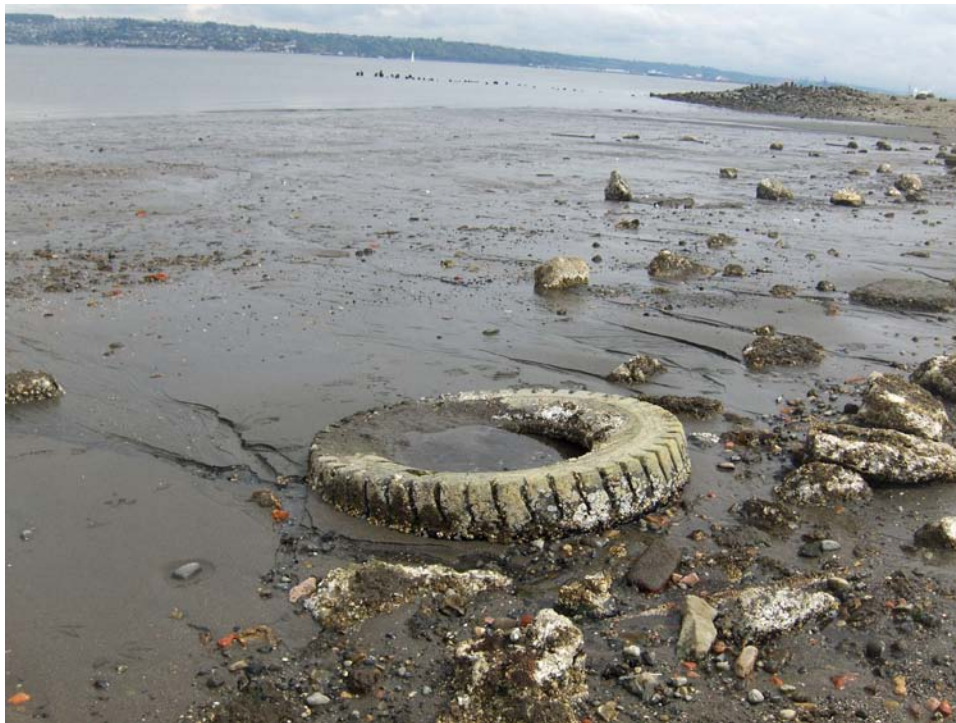
Figure 14. Trash found in AUW1. (Photo by Canyon Little)

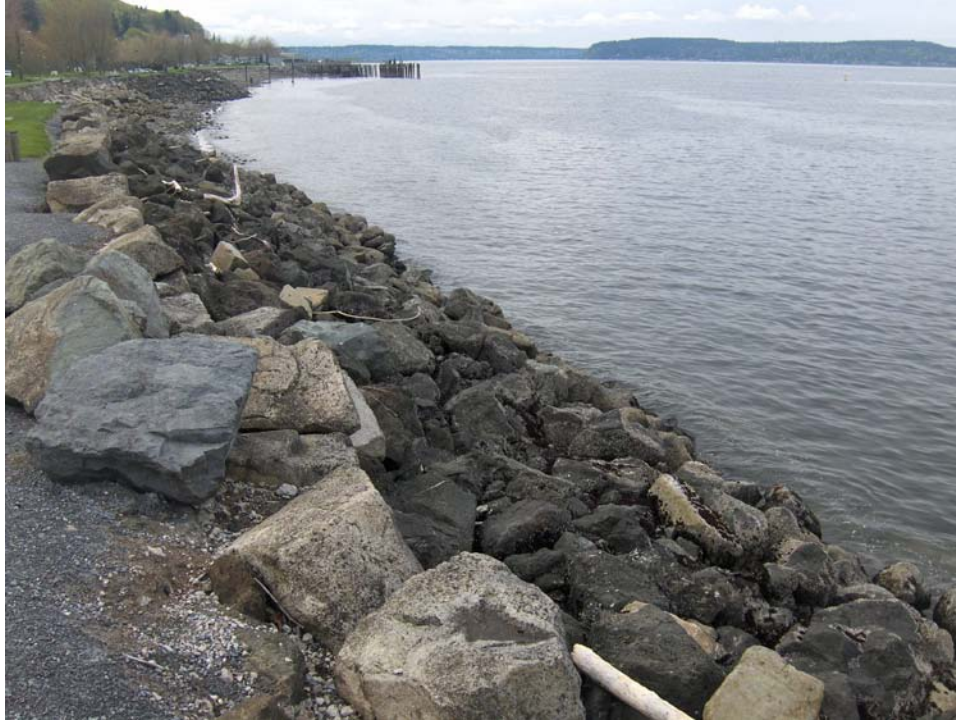
AUW2 is approximately 2600 feet long and contains in its boundaries a small, manmade grass park. It is otherwise mainly comprised of large riprap that extends below ordinary sea level (Figures 15 and 16). Along this large AU there is also a stretch of mixed-substrate beach that contains a number of old creosote pilings. There are a number of large overwater structures contained in this AU, including a restaurant and a large, old pier. There is no riparian vegetation and limited freshwater input.

Figure 15. AUW2 is dominated by riprap shoreline armoring. (Photo by Canyon Little)

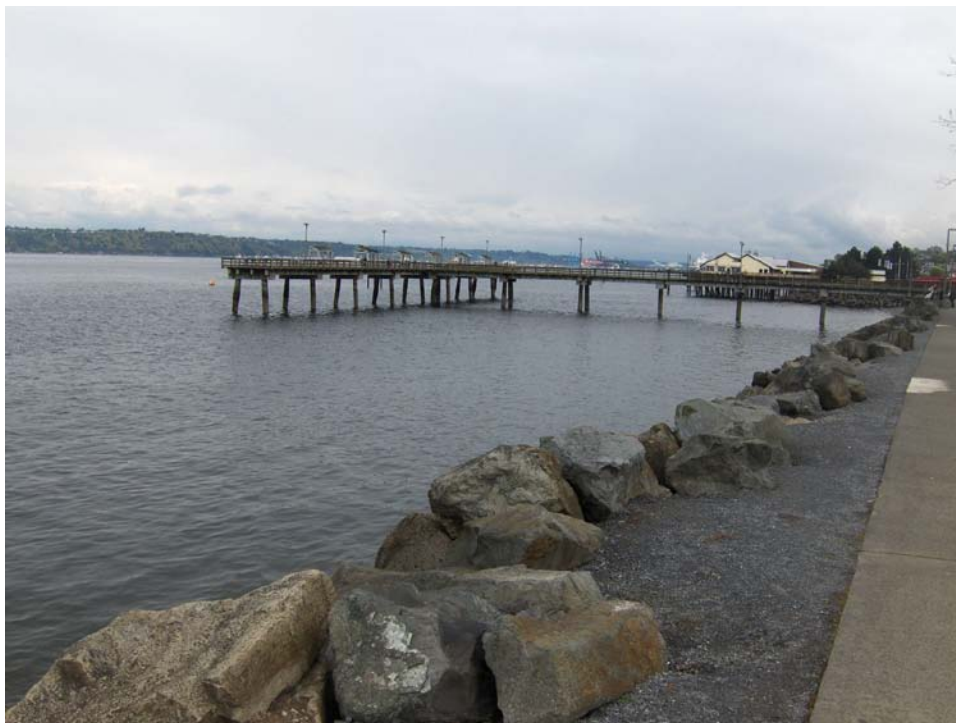
pier that contained many pilings and occupied a large area over the water (Figure 16), leading to additional negative multipliers. Mason Creek empties into this AU through a smaller culvert that flows under Ruston Way. This AU is also sheltered due to its angle in the Bay.

Figure 16. AUW2 is dominated by riprap shoreline armoring. A long pier is located within this AU. (Photo by Canyon Little)

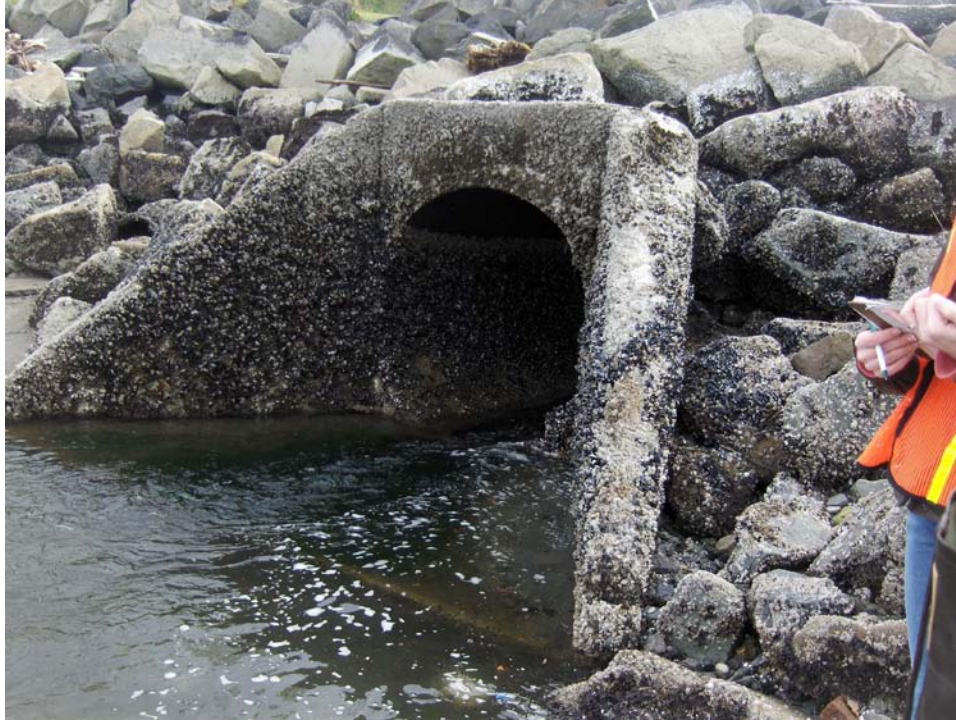
AUW3 is the location of the Puget Creek culvert (Figure 17). It is the smallest AU on the west side (approximately 1000 feet). The beach around this area is mainly sand. The beach ends at a heavily armored interface parallel to Ruston Way, surrounding the culvert. The grade of this beach is low to moderate. Within and directly in front of the waters of the Puget Creek culvert are several rich patches of eelgrass. Like the other AUs, this site contains no riparian edge or salt marsh, and has very limited large woody debris.

Figure 17. A culvert serves as the exit point of Puget Creek, found in AUW3. (Photo by Canyon Little)

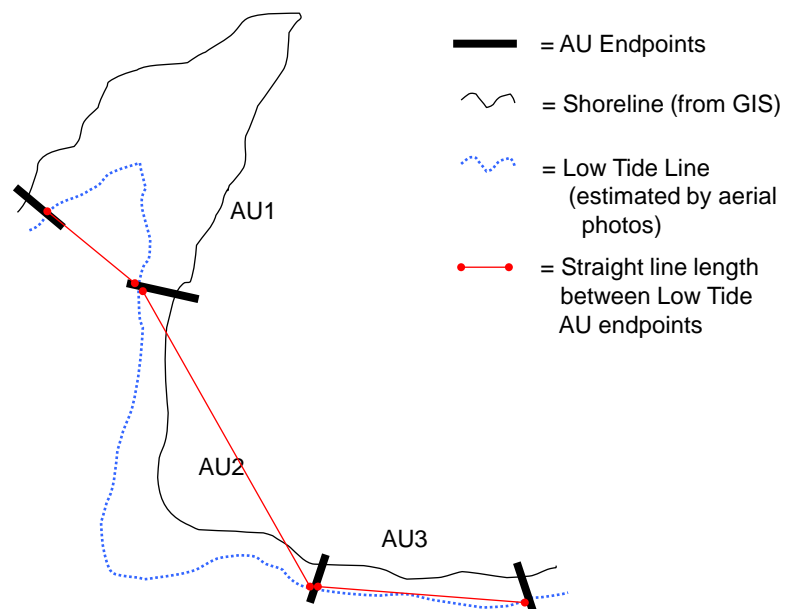
Figure 18. Diagram of how to measure shoreline complexity. Courtesy of Tom Kantz, Pierce County.

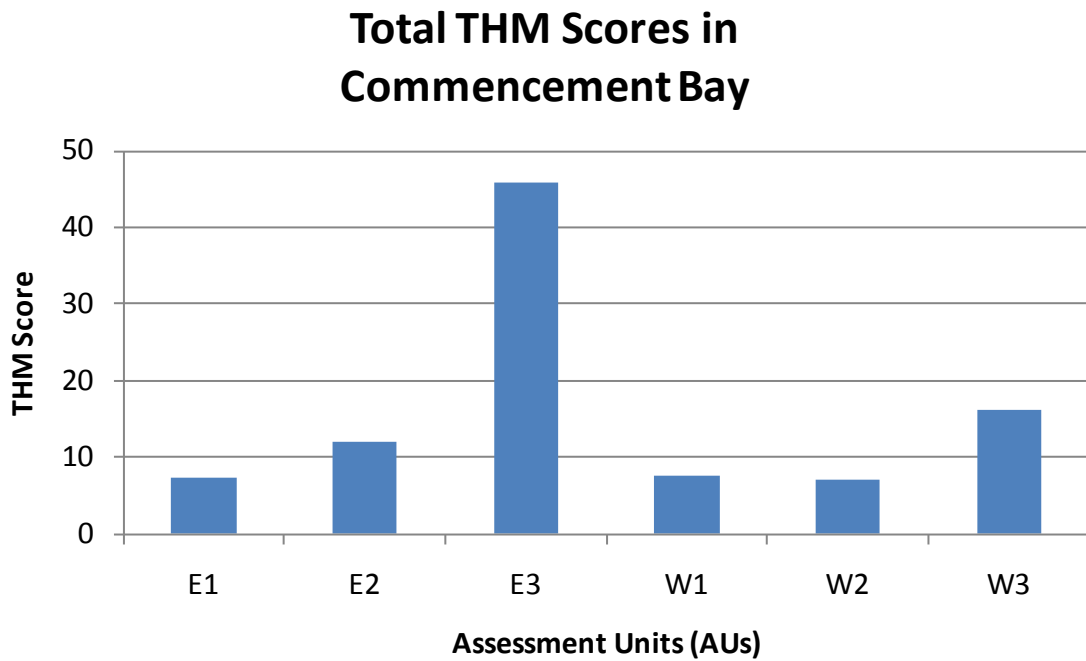
Figure 21. Graph of total scores as determined by the Tidal Habitat Model, comparing eastern and western AUs.

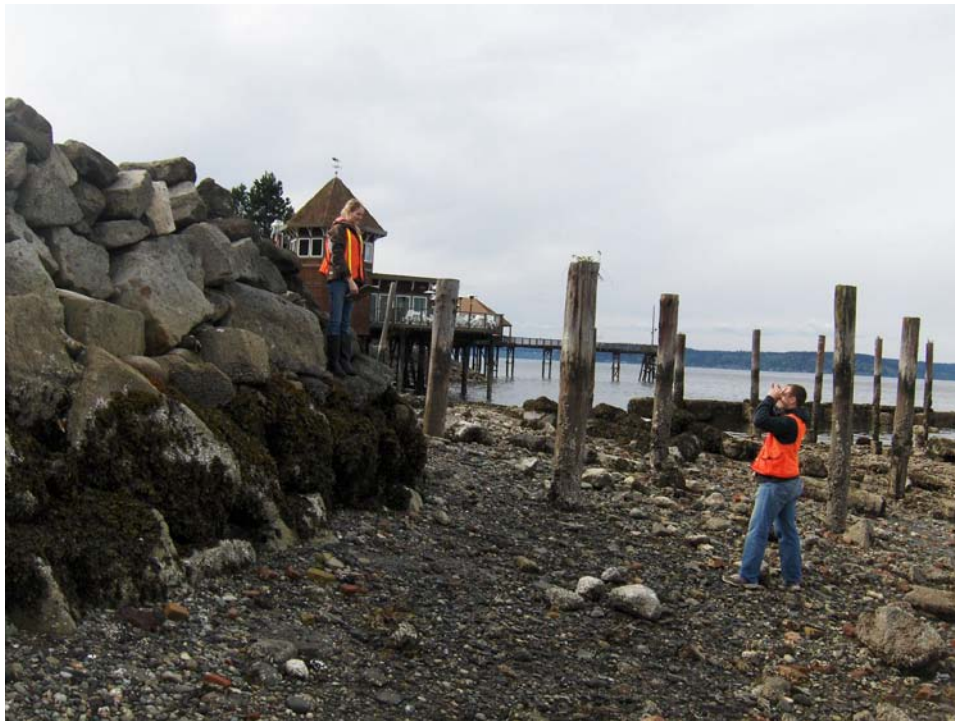
Figure 22. AUW3 with creosote pilings, overwater structure, and intertidal rocks covered with rockweed. (Photo by Canyon)

According to our results, AUW3 has the best conditions for salmon habitat of the AUs on west side of Commencement Bay. It is recommended that the remaining pilings and concrete blocks along the beach be removed, as they pose degradation to the habitats of AUW3. In addition, the creek culvert and the area around it could be improved with soft shore armoring and a more natural transition from creek to sound. The activities of the Puget Creek Restoration Society, plus the existing eelgrass beds in this area, make it a good candidate for restoration. Removal of riprap and the establishment of native riparian vegetation would be a large

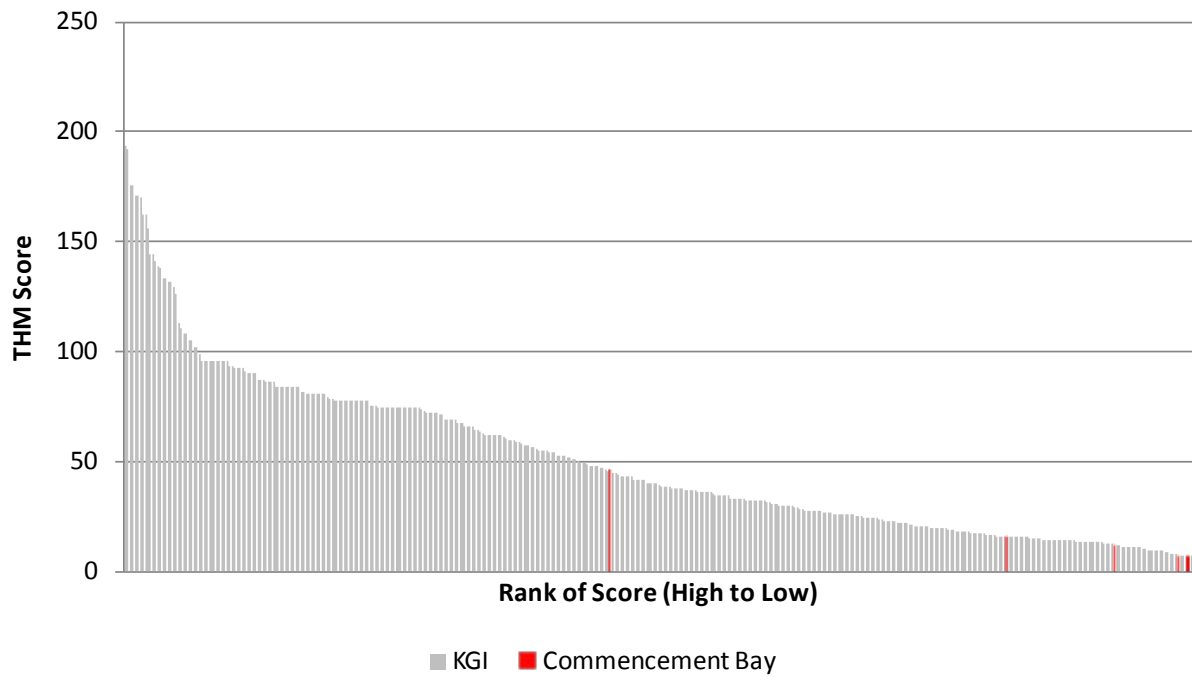
Our six AUs scored quite low compared to these sites (Figure 24). Our best AU, E3, ranked 191 out of 413. Our three worst-scoring AUs, W1, E1, and W2, ranked 413, 416, and 417. It is clear that Commencement Bay habitat is highly modified and has a number of stressors that degrade the habitat quality for Chinook salmon, most notably armoring and overwater structures. However, it is known that these salmon use the Puyallup River as spawning ground, and local juveniles need suitable marine habitat for their first year. There is ample evidence that juvenile fish spend a significant amount of time in Commencement Bay (Olson *et al.* 2008, Ridolfi 2009).

Figure 24. Comparison of scores from the current study to scores from Houghton *et al.* (2003) in the Key Peninsula, Gig Harbor, and Islands (KGI) region (Figure 1). All scores were ranked from high to low. KGI AUs are shown in grey, while Commencement Bay sites are in red.

Although the THM scores are meant to be used to compare relatively similar sites, it is illustrative to compare our scores to those found by Houghton *et al.* (2003) in the Key Peninsula, Gig Harbor, Islands Watershed (Figure 1). In that report, the average score of the 413 AUs was 51.0, with a standard deviation of 36.4. The minimum score found was 6.8 and the maximum was 193.5.
