# CASE STUDY

## Confined Space Entry - Worker and Would-be Rescuer Asphyxiated

No. 2006-02-I-DE

## Valero Energy Corporation Refinery

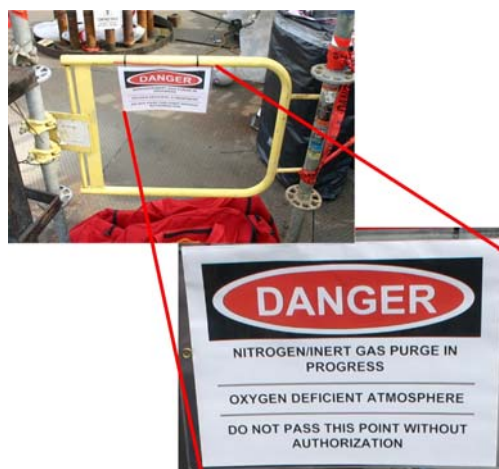
**Figure 8. Nitrogen-purge controlled area barricade and warning installed on the R1 platform after the incident.**

The Valero refinery has safe work procedures for using nitrogen, but they were inadequately implemented the night of the incident. The procedures required operators to install a barricade and post warning signs at all equipment access points (Figure 8) before the nitrogen purge was started, and to list all personnel working inside the barricaded area using a controlled area entry log. The barricade and control log were not used at the R1 manway the night of the incident, even though the reactor was on a nitrogen purge that vented directly onto the work platform area.

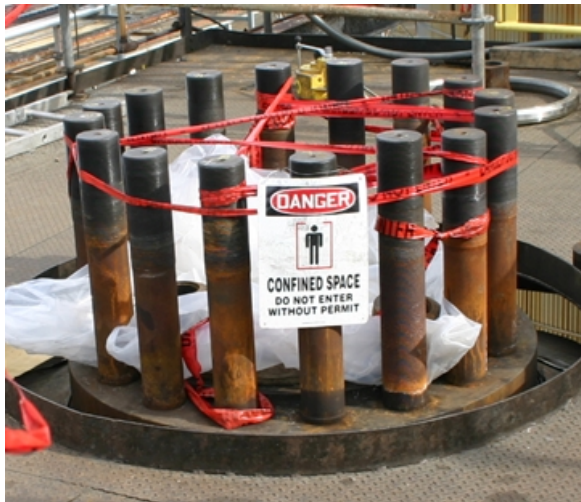
**Figure 11. Confined space warning sign on the unsecured reactor manway after the incident.**

The employer is also required to post danger signs (Figure 11) or other equally effective means to identify the hazard [§146(c)(2)]. In this incident, the red tape was the only warning on the manway—no warning sign was in place at the time of the incident.
