Earthquake Engineering and the Alaskan Way Viaduct

Steve Kramer
University of Washington
Seattle, Washington

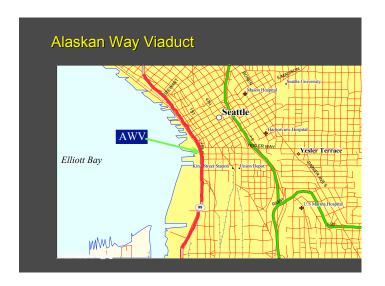
Alaskan Way Viaduct • 2.2 miles long • 86,000 vehicles per day • North of Yesler Designed by City of Seattle Constructed in 1950 • South of Yesler Designed by Washington State DOH Constructed in 1956

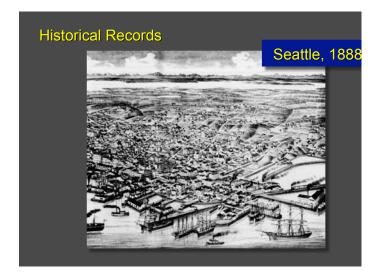
- Review of historical records
- Review of previous subsurface investigations
- Supplemental subsurface investigations
 - SPT
 - CPT
 - Seismic cone
 - Downhole seismic

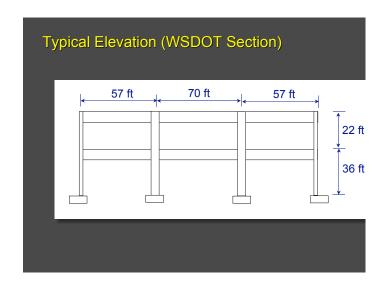
Alaskan Way Viaduct History Originally intended as downtown bypass Design began in 1948, bids opened 1949 Seattle section opened April 4, 1953 WSDOT section opened Sept 3, 1959 Seneca Street off-ramp opened 1961 Columbia Street on-ramp opened 1966 Facts 7,600 ft long 58,867 yards of concrete, 7,460 tons of rebar 171,410 ft of piling

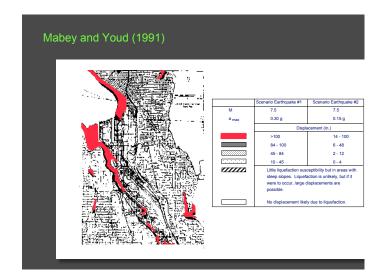
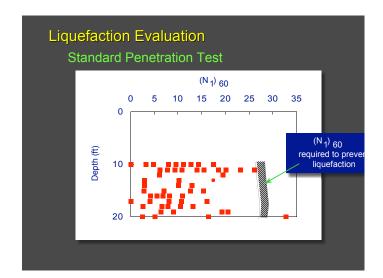
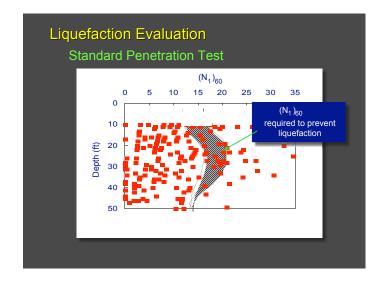
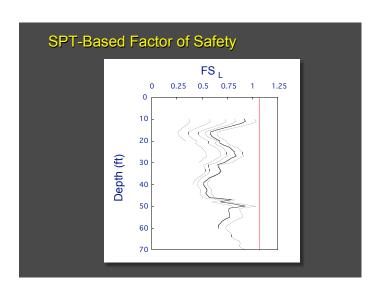
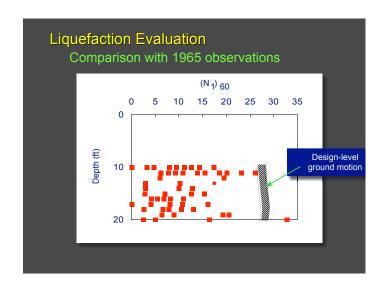
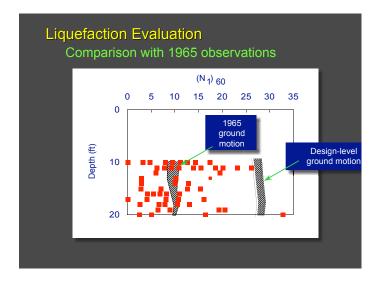
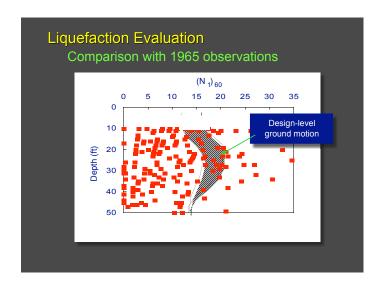
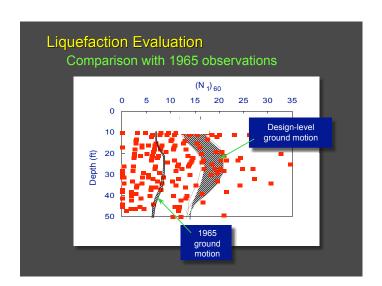
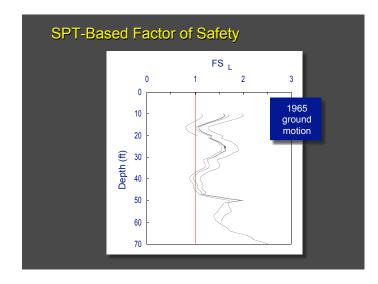
Liquefaction Susceptibility

- Historical evidence
 - Sand boils in 1949 and 1965
 - Broken pipes in 1949 and 1965
 - Lateral movements in 1965
- Construction techniques
 - Hydraulic filling
 - Dumping through water
- Previous investigations
 - Mabey and Youd (1991)
 - Grant et al. (1992)

- Sand boils expected over most of length
- Post-earthquake settlement
 - Up to 1" in fill above water table
 - Up to 25" in soft, saturated soils
- Vertical pile movement
 - Tip capacity reached at r_{..} = 0.6
 - Tips of southernmost piles in liquefiable soil
- Lateral pile movement
 - Depends on lateral soil movement
 - 10"-12" expected to cause bending failure
 - Lateral soil movement depends on seawall movement

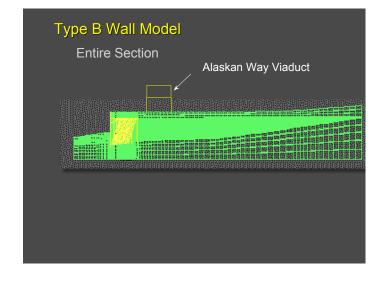
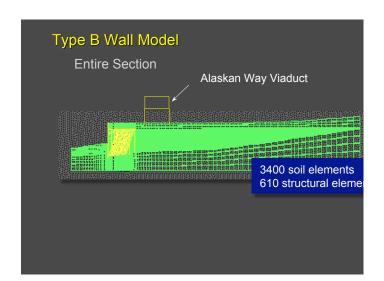
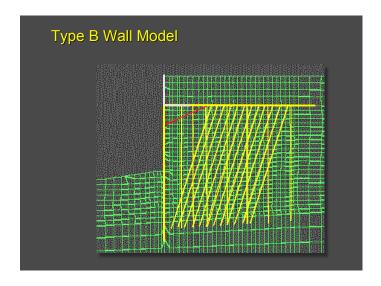
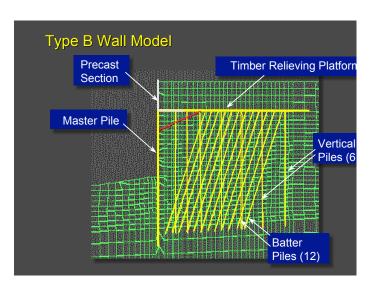
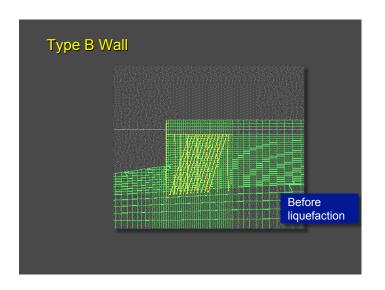
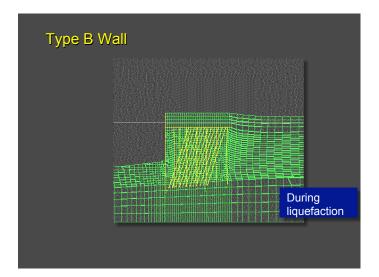
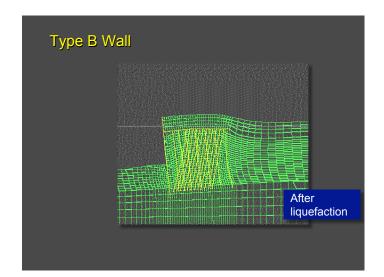
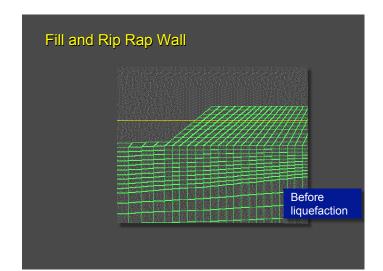
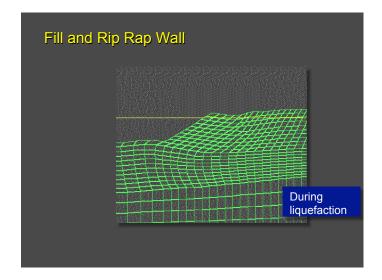
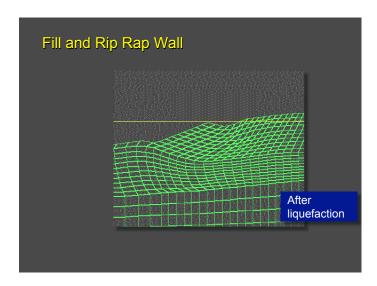
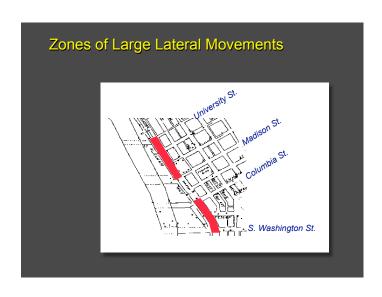
Seawall Investigation

Estimation of permanent deformations due to liquefaction

- Transverse profile characterization
 - 5 additional borings (2 offshore)
 - 3 additional CPT soundings
- Seawall structure characterization
 - Member sizes
 - Member properties
 - Connection strengths
- Computational model
 - Soil
 - Seawall
 - Soil-seawall interaction

FLAC Fast Lagrangian Analysis of Continua • Explicit finite difference code • Large-strain capabilities • Several soil constitutive models • Structural elements (beams, piles, cables) • Interface elements (normal and shear) • Coupled stress-deformation and flow capabilities • Incremental construction modeling • Graphical display of results • Dynamic option • Creep option

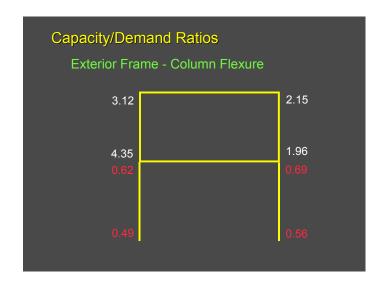
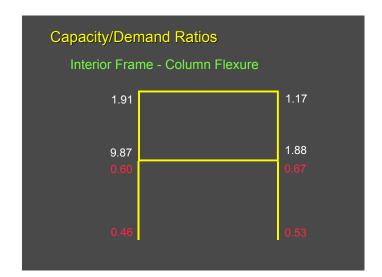
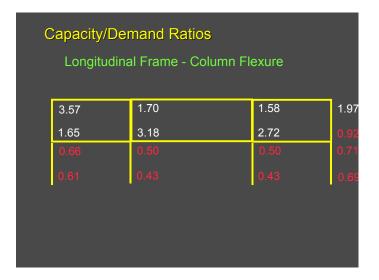
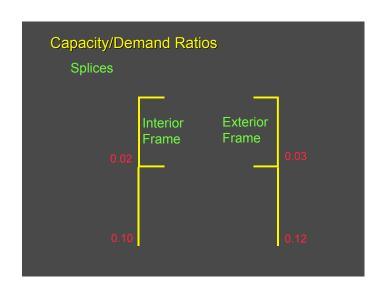
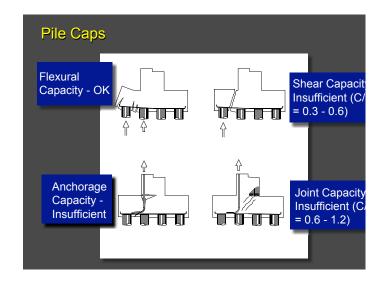
Structural Aspects of Seismic Vulnerability Dynamic Response Spectrum Analyses Nonlinear "Pushover" Analyses Investigated capacities and demands for: Flexure (beams and columns) Shear (beams and columns) Splices Joints Pile Caps

- Lower-level splices highly vulnerable
- Joints highly vulnerable
- Columns shear capacity marginal
- Footings vulnerable to brittle failure
- Special sections require additional investigation
 - Outrigger bents
 - On/off ramp sections
