Road Reconnaissance Report

Road Name: Nettle Meadows

St. Edward's Park
Road Location

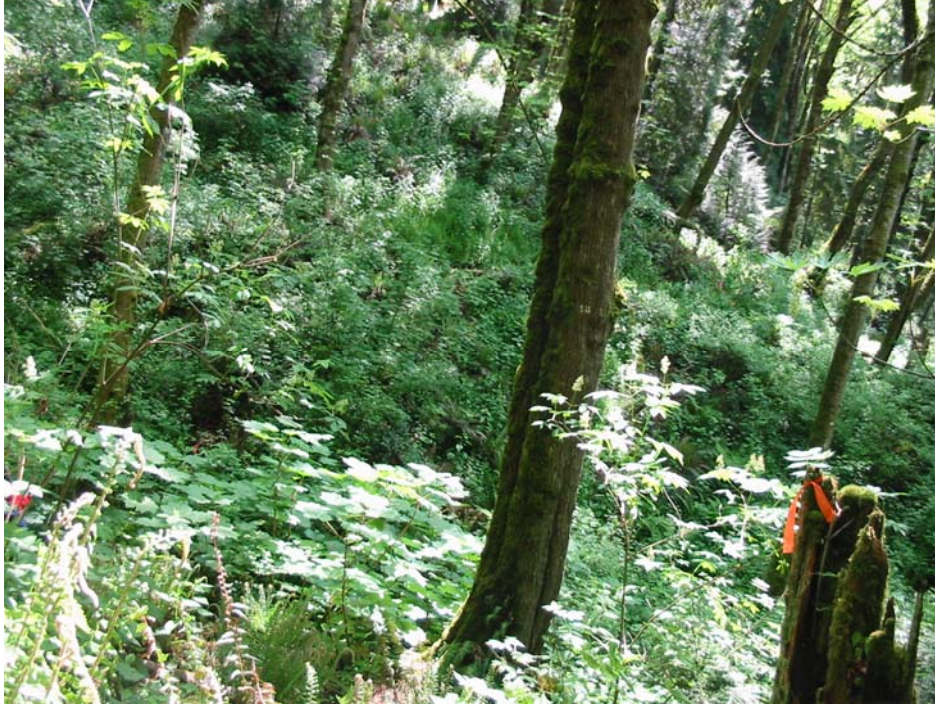
Stream Crossing: There were two stream crossings. The first stream crossing started at Station 6+70 and ended at Station 8+45. The second stream started at Station 11+50 and ended at Station 12+40. Both stream crossings were in the form of a curve. The first stream crossing curve was marked using 25 ft cords and a 60 ft curve radius. The second stream crossing curve was marked using 30 ft cords and a 50 ft curve radius.

Figure 1: Looking across second stream crossing from Station 12+50 to Station 11+50.
